St. Rose of Lima Catholic Church/Chamber of Commerce

HISTORIC STRUCTURE ASSESSMENT

SHF PROJECT NUMBER 2018-HA-020

FINAL HISTORIC STRUCTURE ASSESSMENT – DELIVERABLE #5

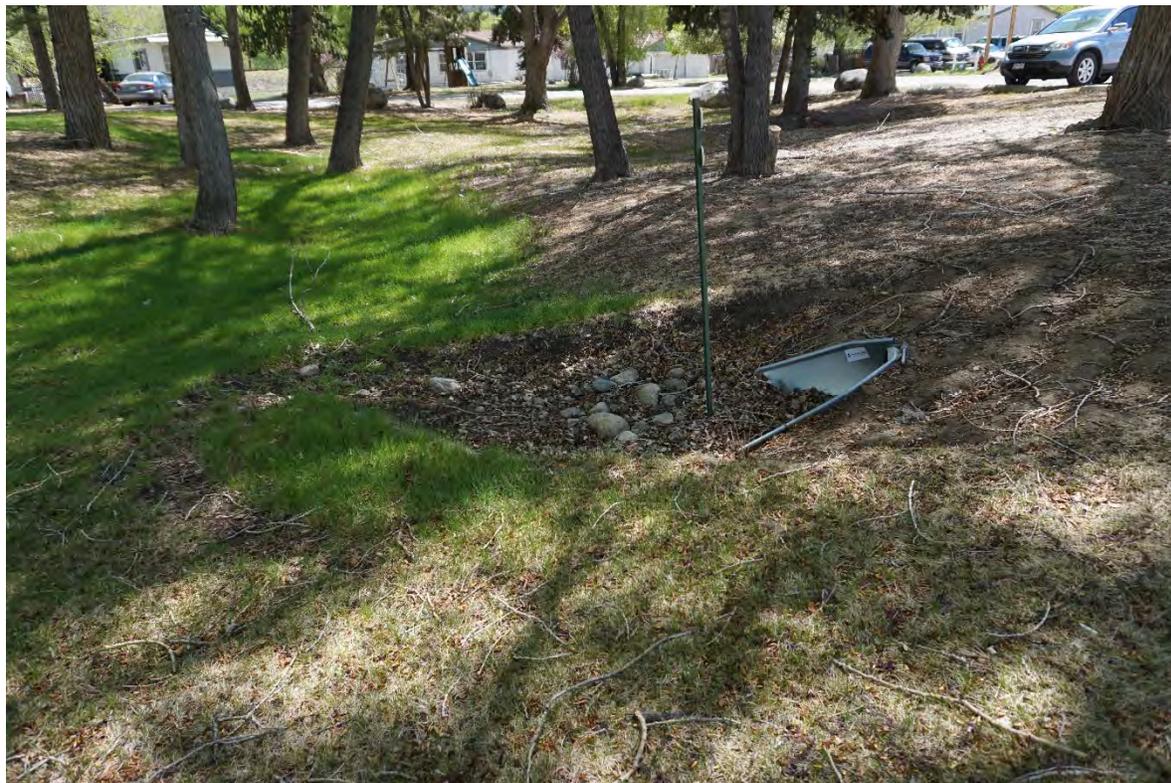
4.0 Drainage Outlet on the South Side of the Building, Empties Into Drainage Swale

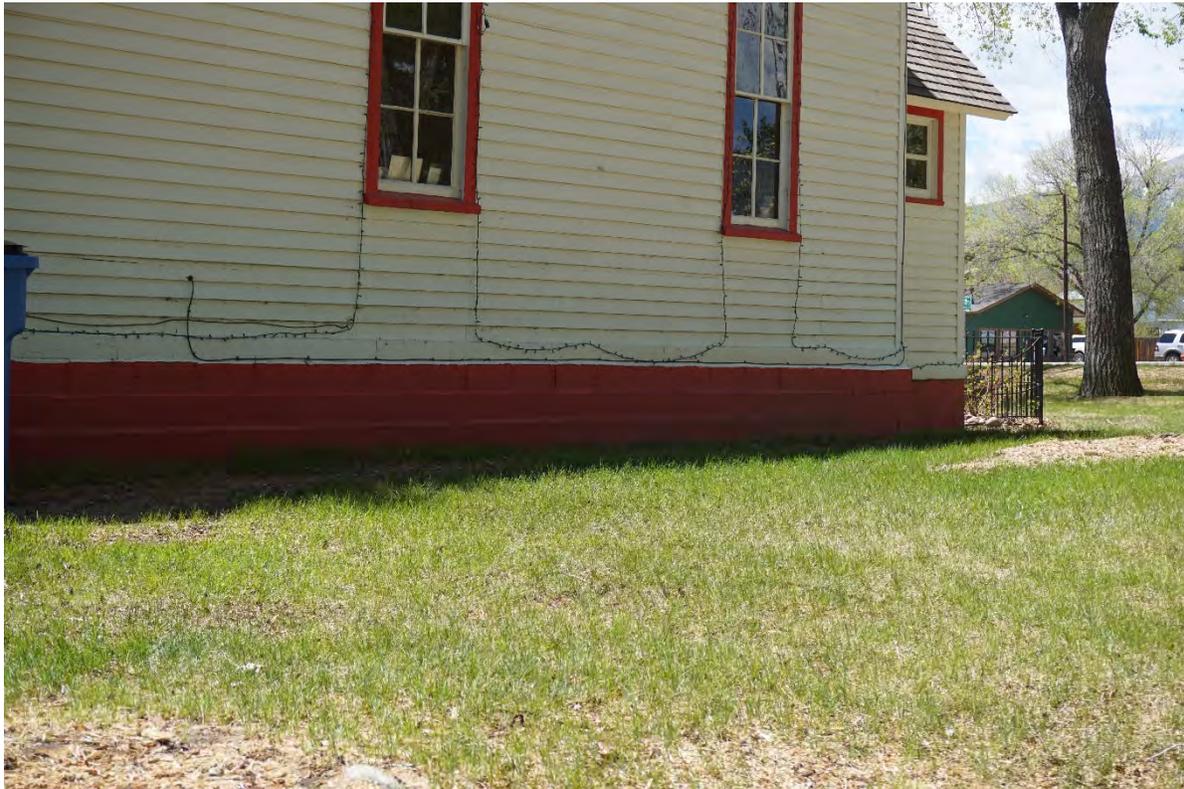
The site is in fair condition. The trees, bushes and grass all look healthy and well maintained. The grade around the building appears to be unlevel, particularly on the north and west elevations where there are areas that drain back toward the building. The slope back toward the building on the west is less than on the north side of the building. According to the former Chamber Director, Kathi Perry, the building is an island in the park when it rains. Water stands to the north and south and even to the west when it rains. The large drainage channel fills with water and water does not drain on the north side of the building.

7.0 North Elevation – Grass Up to Building; Grade Slopes Towards Building

To protect the building, regrade around the building, especially on the north elevation to provide positive drainage away from the building. Relocate the planting bed and drip irrigation away from the porch foundation to prevent water from standing against the building. Also regrade on the west elevation to provide proper positive drainage away from the building. A minimum slope of 6" in 10' is recommended by *Preservation Brief 39: Holding the Line: Controlling Unwanted Moisture in Historic Buildings*. In addition, the Town of Buena Vista should study the drainage patterns in the park to determine if there is an optimum way to drain the park to prevent the standing water from impacting the building in the future or in a significantly heavy rain, especially on the north elevation.

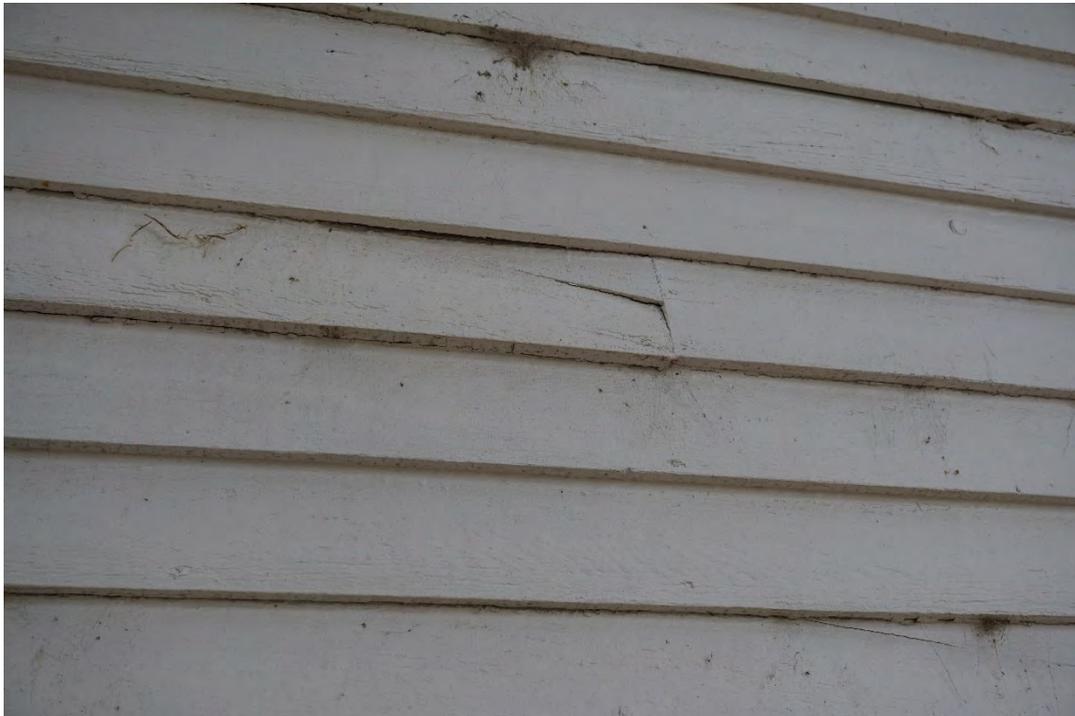
Church: The church siding is in fair condition. There are areas of split wood and buckled siding and there is evidence of previous heavy weathering. The same is true of the corner trim. There is heavy weathering of the previous paint finish and the wood itself. Additionally, there is also a gap between the water table board and the concrete block foundation where a wood sill or rim joist exists. It appears that in many locations, the wood sill plate/rim joist has rotted and no longer exists. Expanding foam has been installed in the gap. The current paint finish is in fair condition. The paint is beginning to flake in a few locations. The water table board may have been replaced when the building was moved in 1969. It matches the water table boards on the additions. The water table boards, and the painted finish are in good condition. The frieze board is in good condition. There is a small area on the north elevation where the chimney was removed, and a frieze board was installed.

10.0 Split Siding. Siding is Covered in Cobwebs and Insect Nests

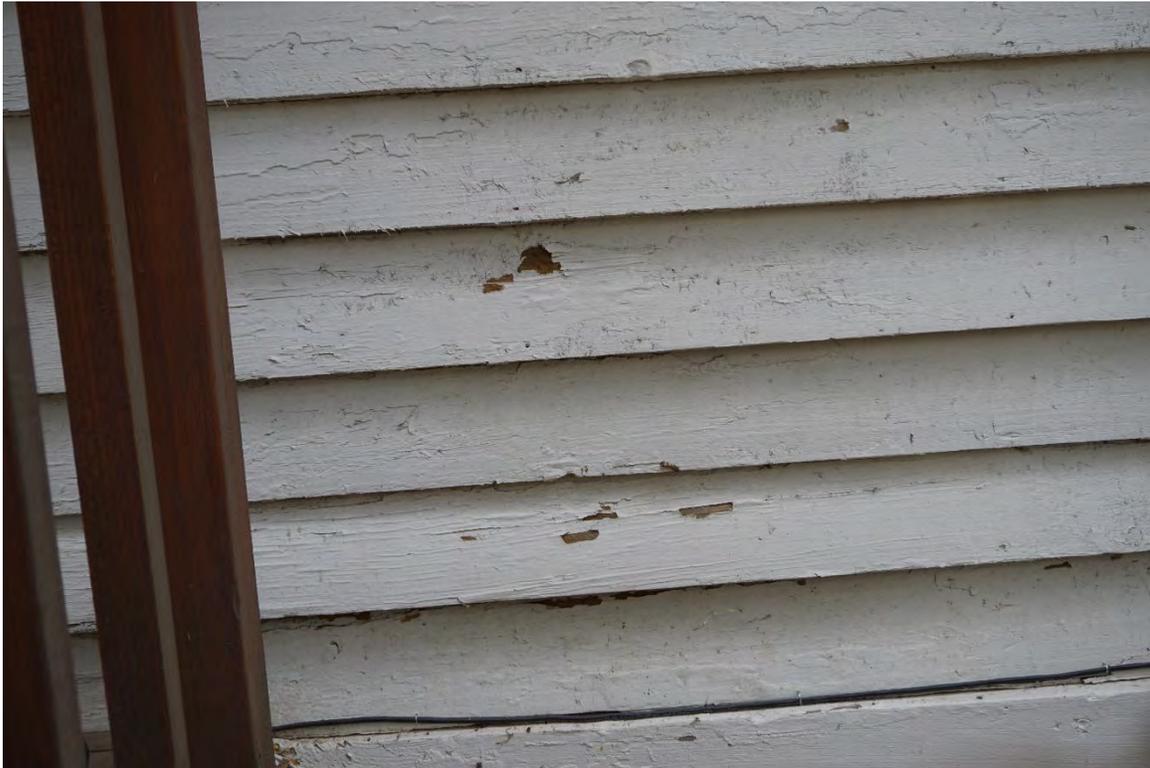
11.0 Paint is Beginning to Peel

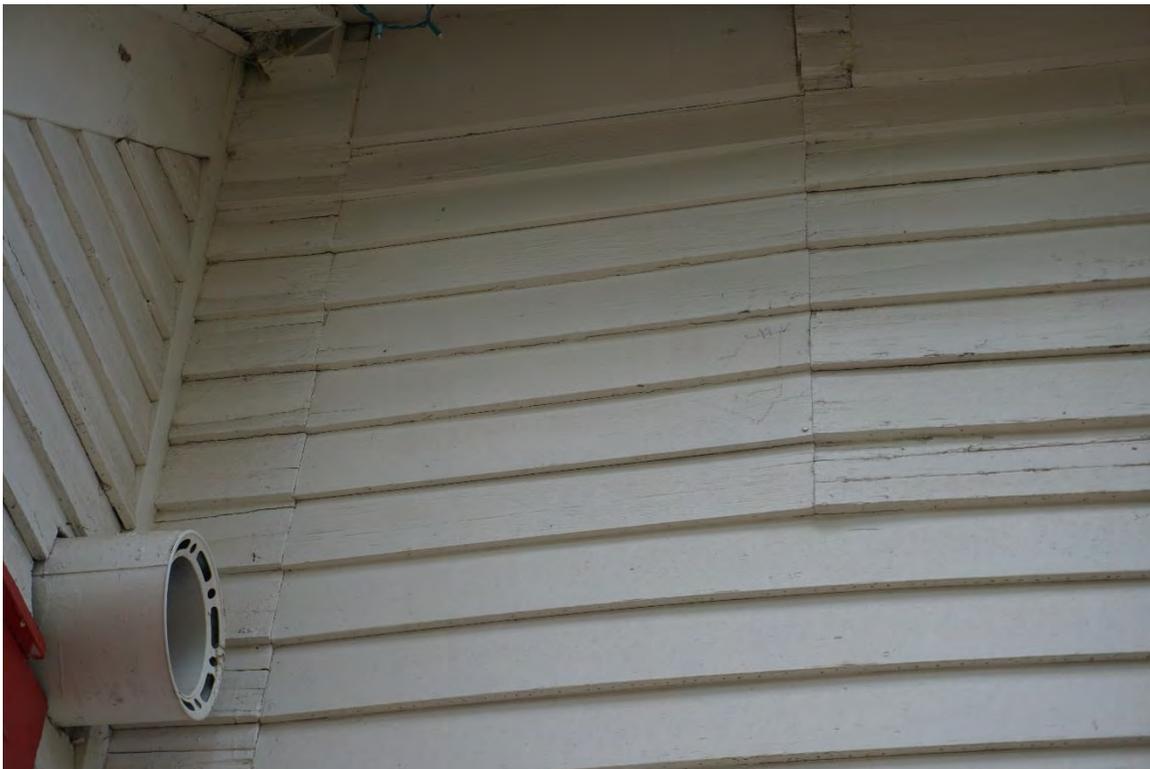
12.0 Location of Former Chimney at North Elevation

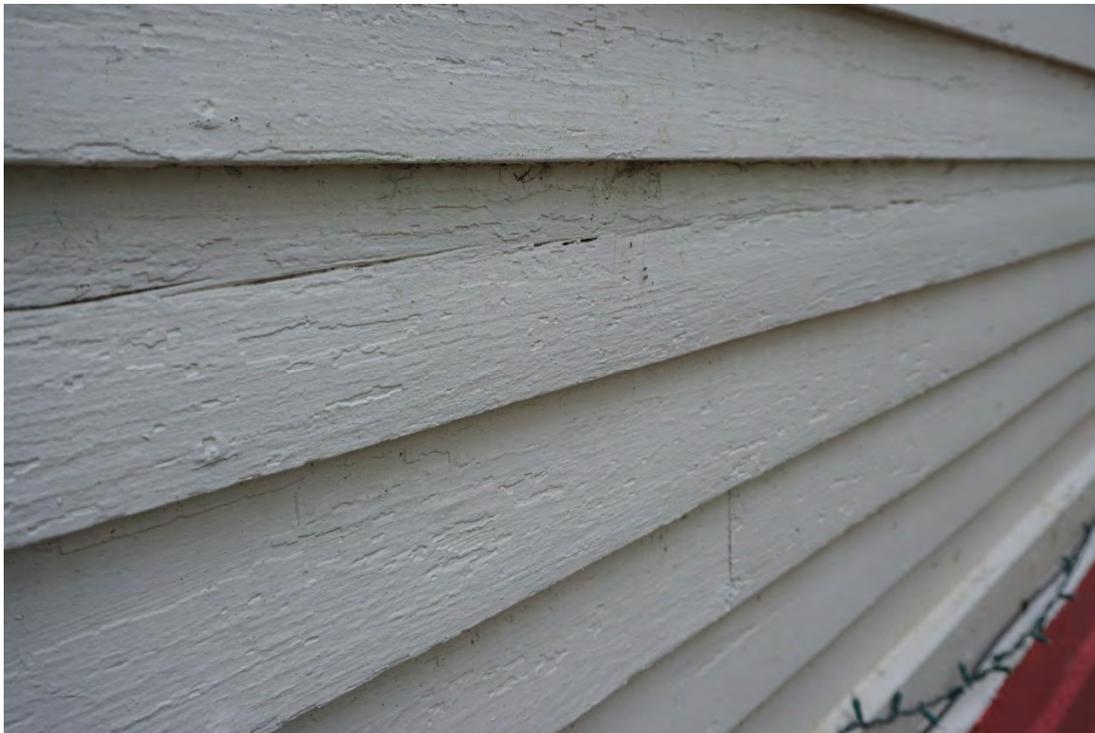
14.0 A Split in the Siding

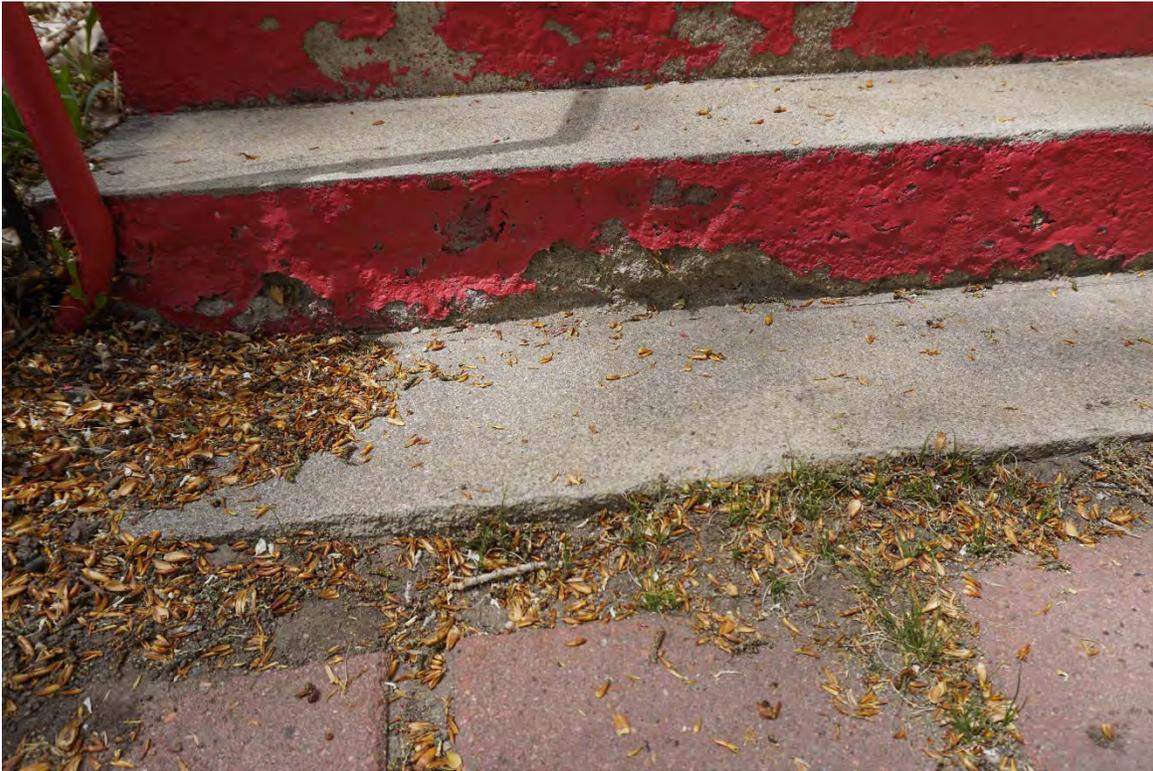
17.0 Peeling Paint and Spalling Concrete at West Elevation Stair Riser

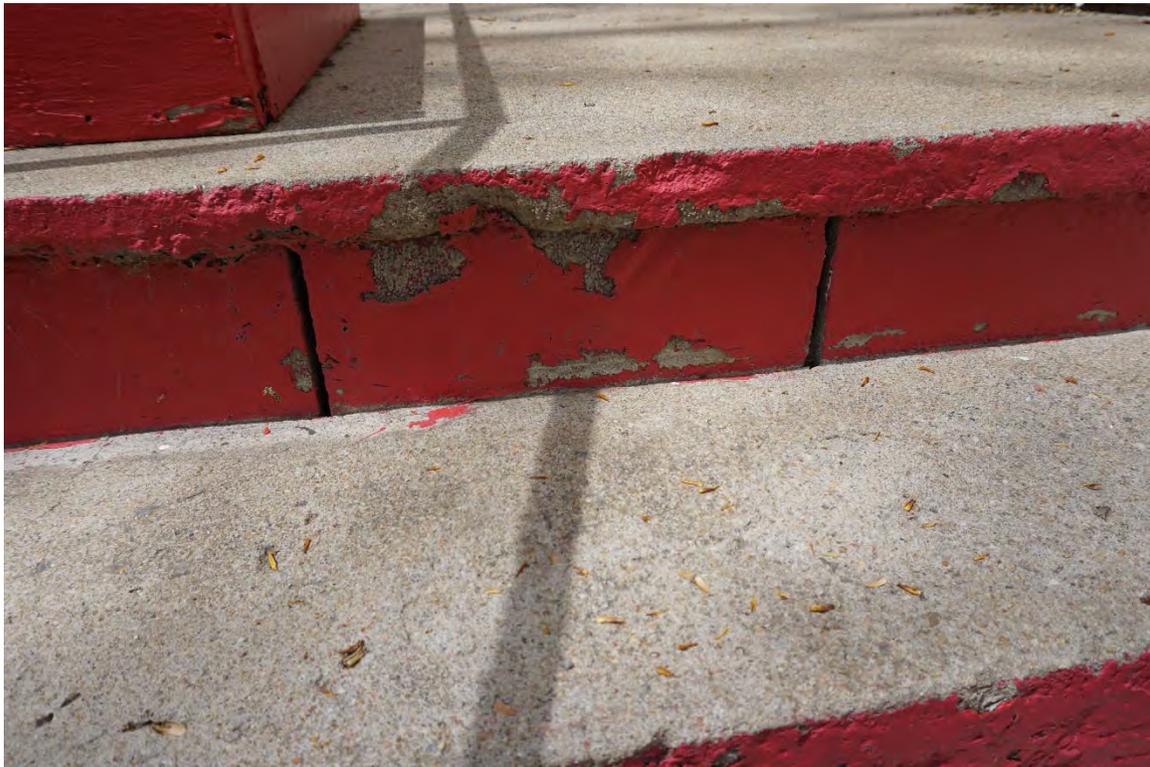
18.0 Peeling Paint and Spalling Concrete at West Elevation Entrance

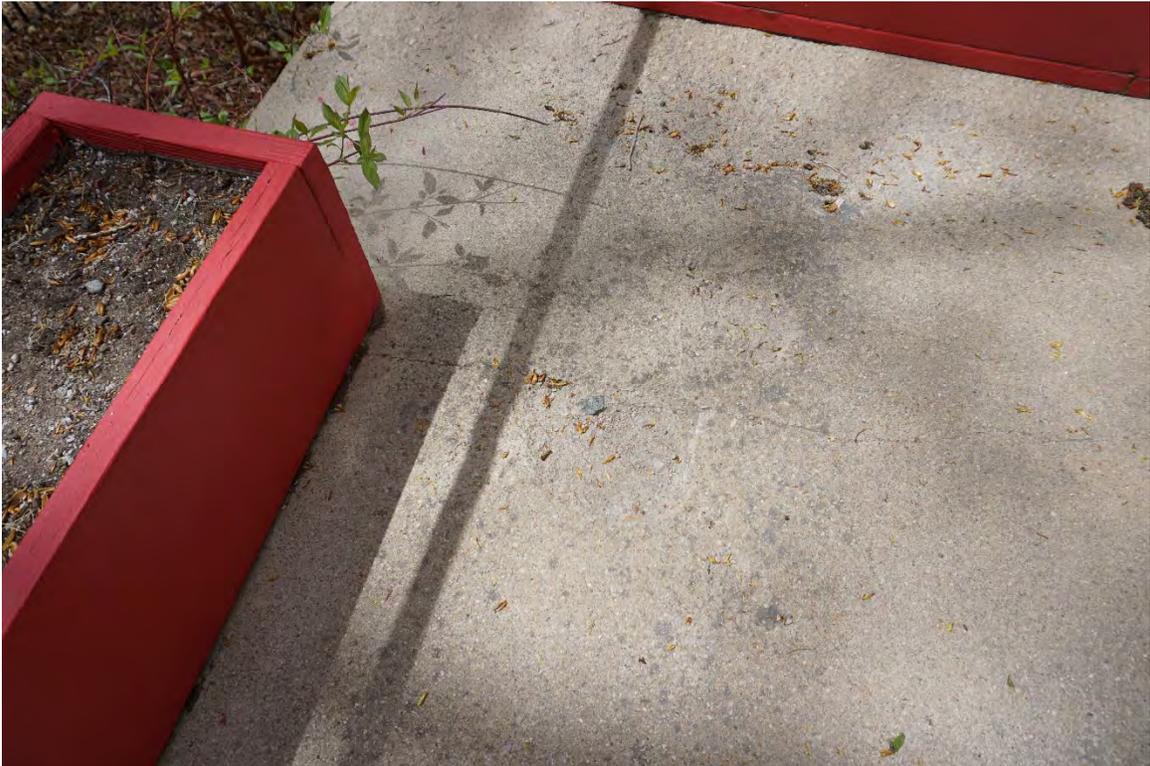
19.0 Spalling Concrete and Small Hairline Crack

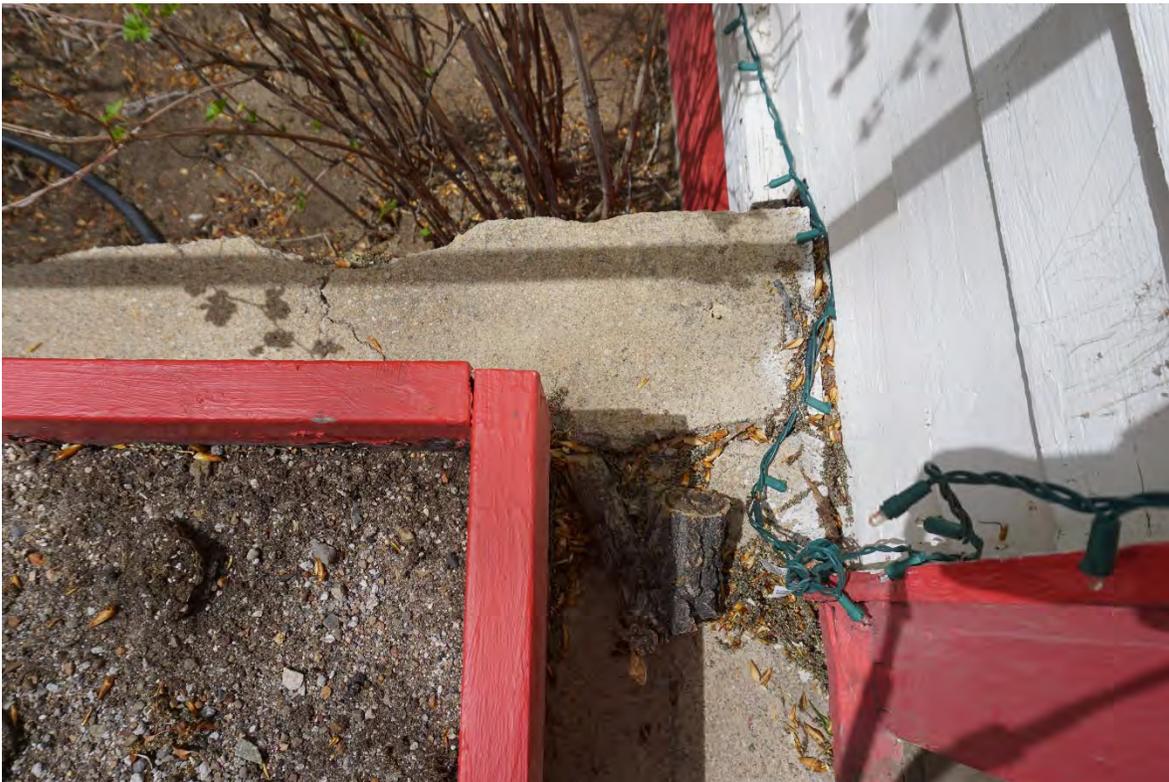
20.0 Deterioration of the Concrete Deck – Spalling, Chipping

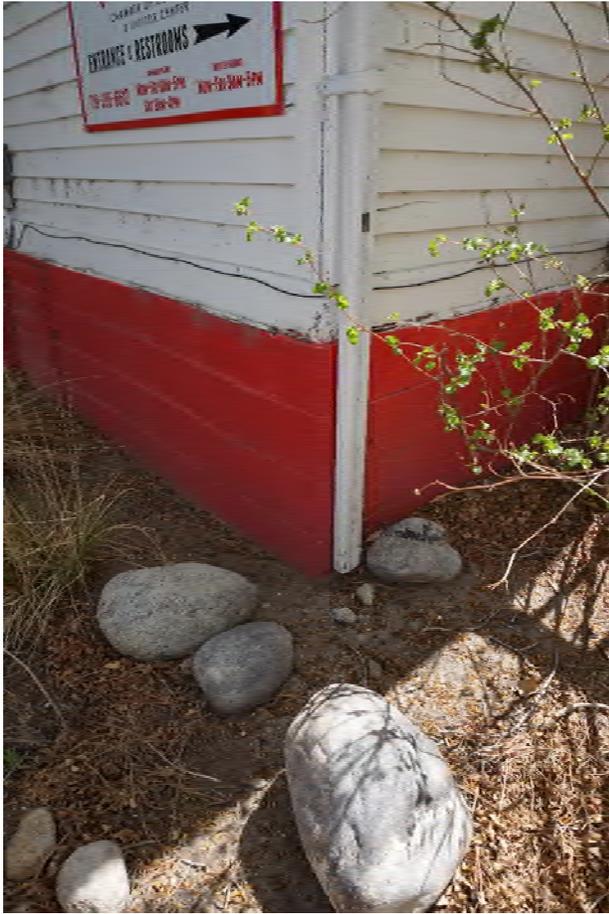
21.0 Downspout Drops Water at Base of Building

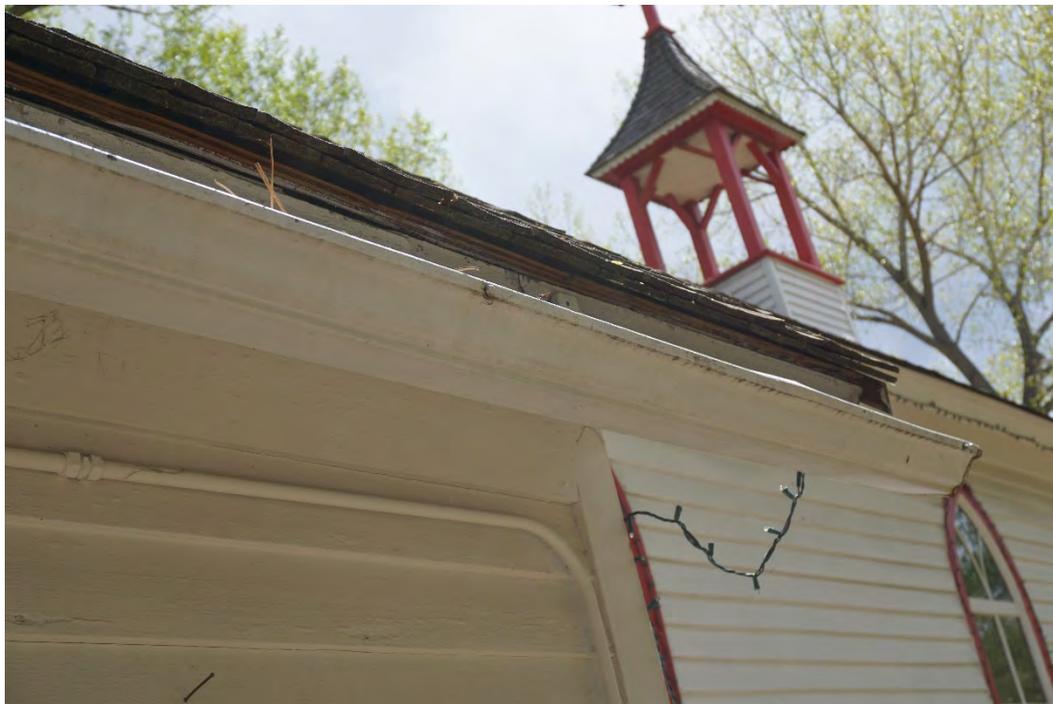
22.0 Deteriorated Gutter and Fascia at North Elevation From Ice Damming

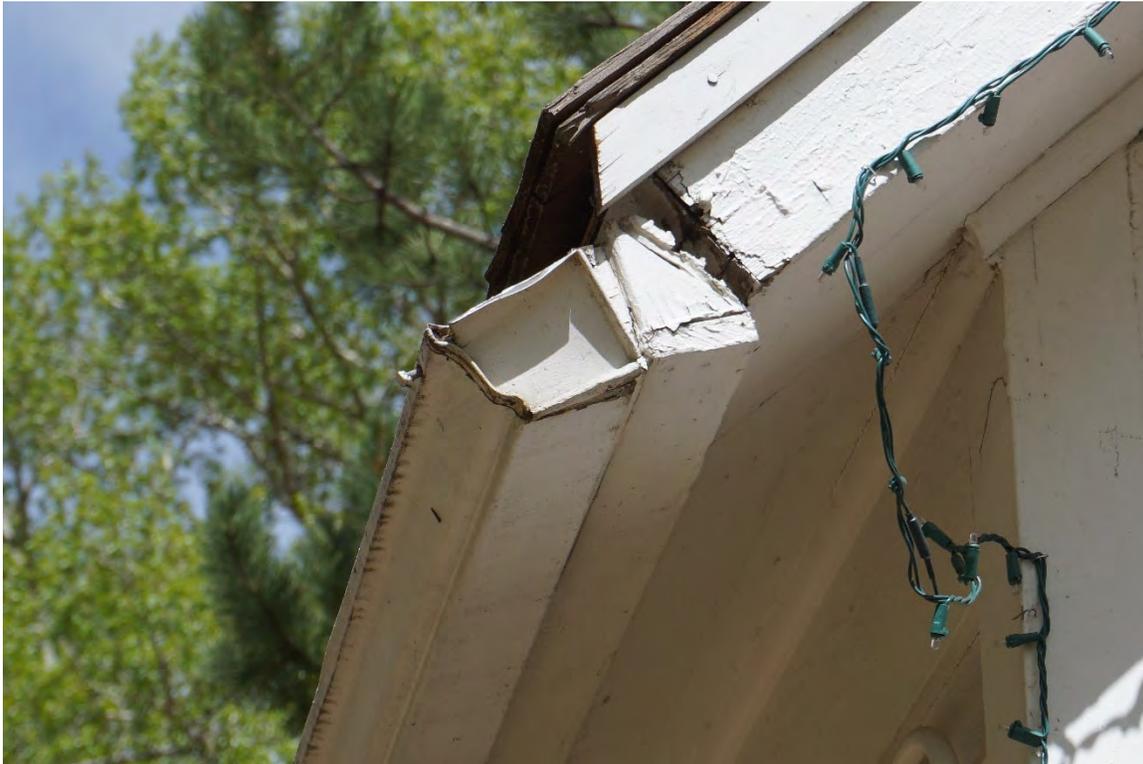
23.0 Damaged Gutter and Fascia at North Entrance From Ice Damming

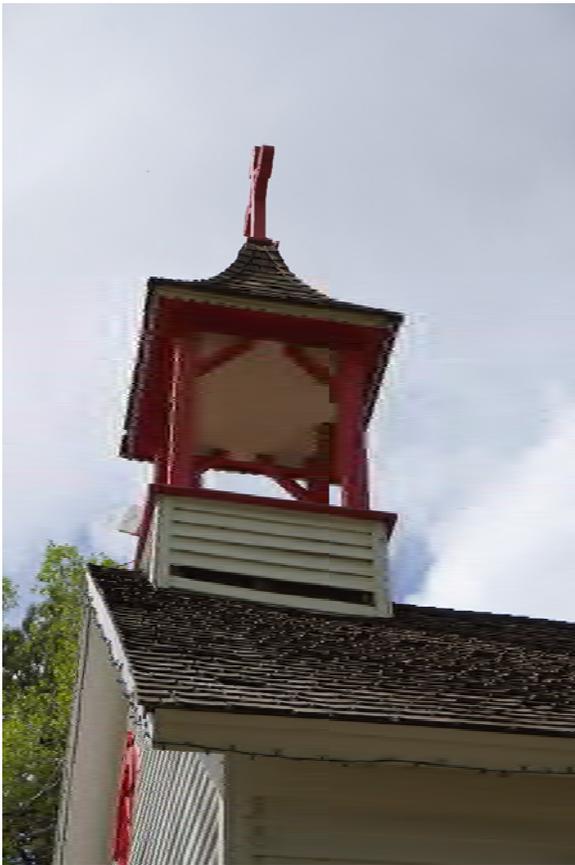
25.0 Bell Tower – Missing Siding

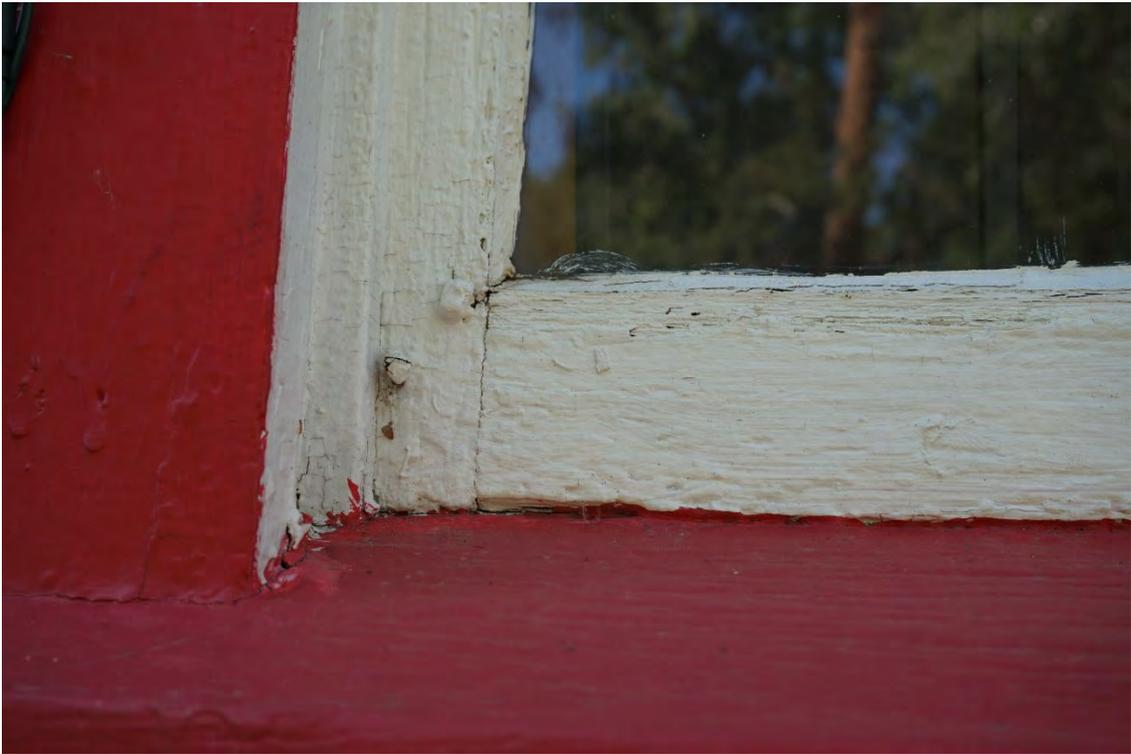
44.0 Open and Weak Joint. Poor Glazing Putty

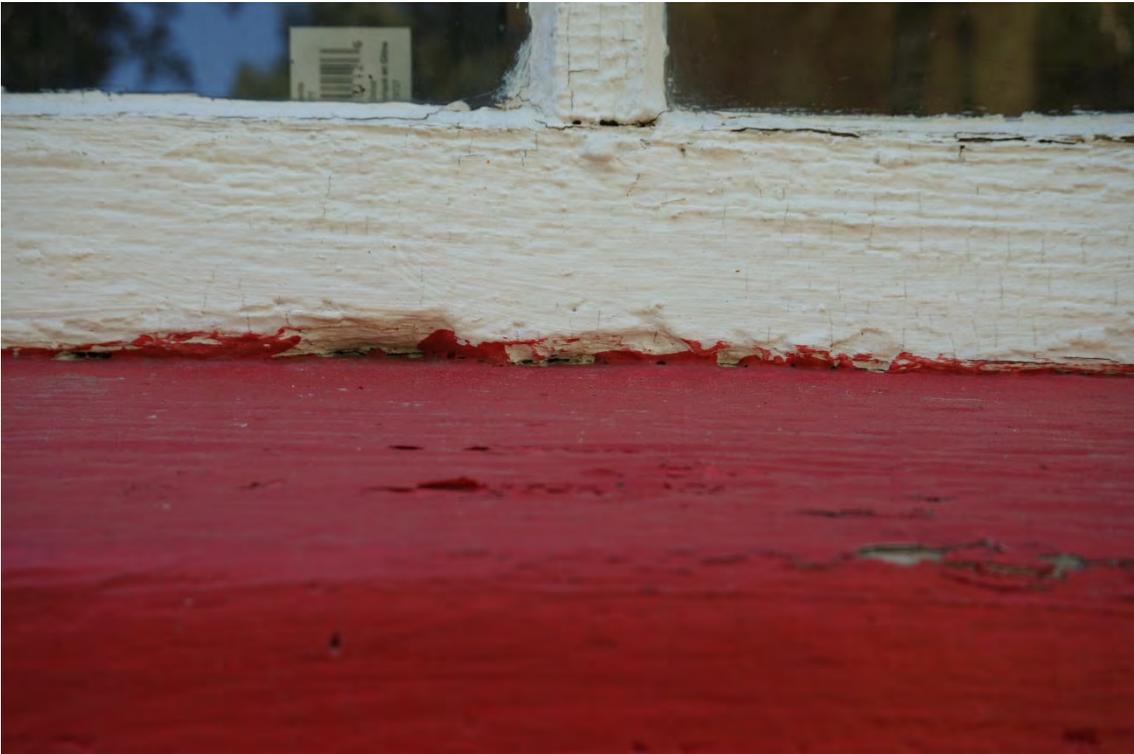
45.0 Open and Weak Joint. Poor Glazing Putty

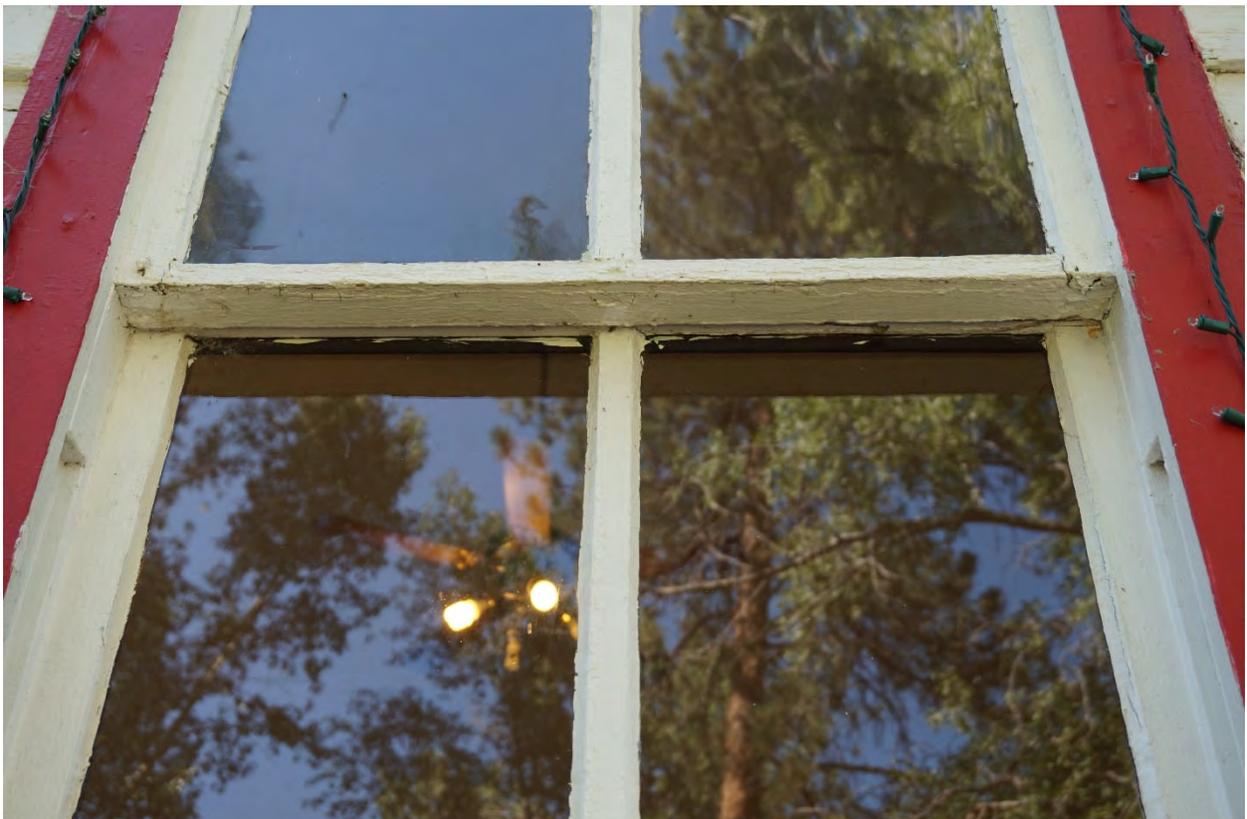
47.0 Open Joints at the Meeting Rail

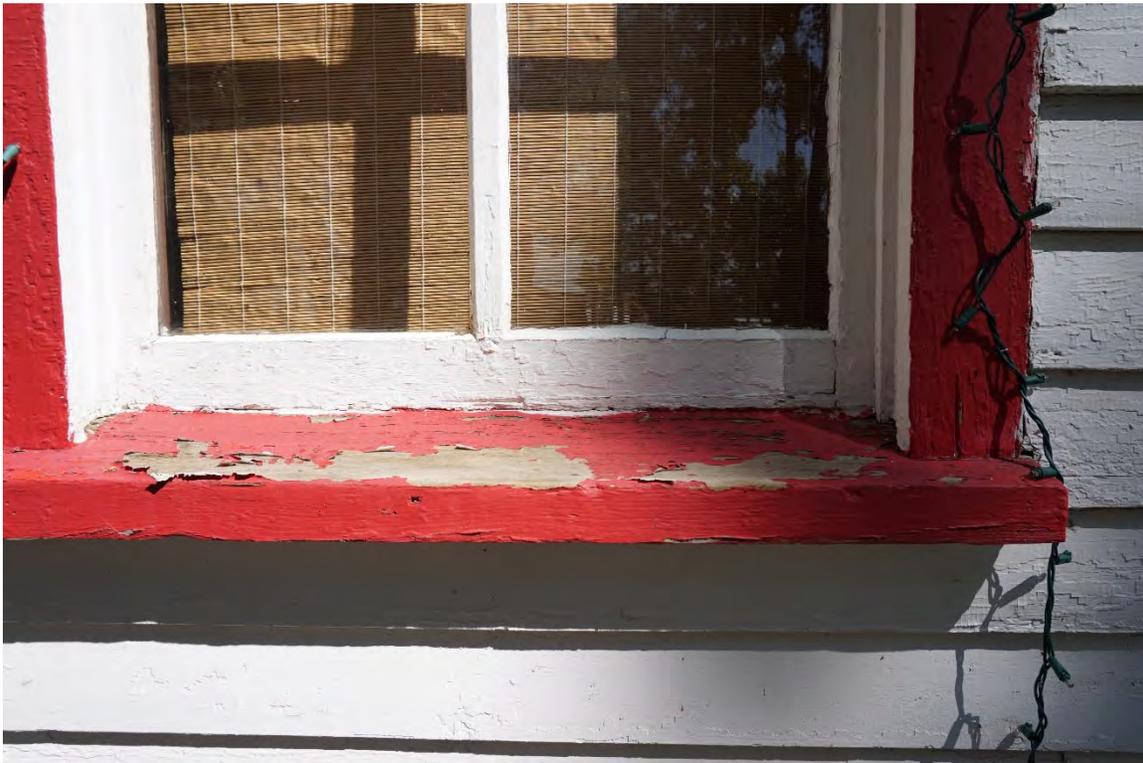
48.0 Peeling and Deteriorated Paint. Poor Glazing Putty

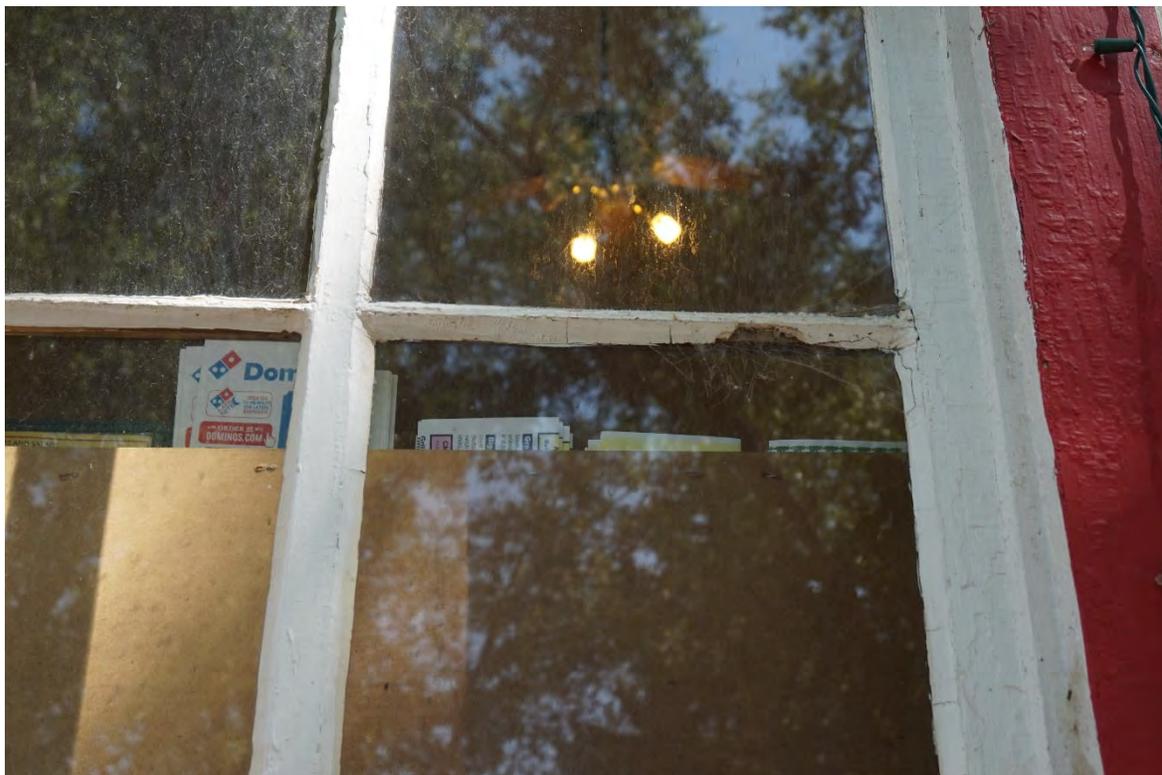
49.0 Poor Glazing Putty

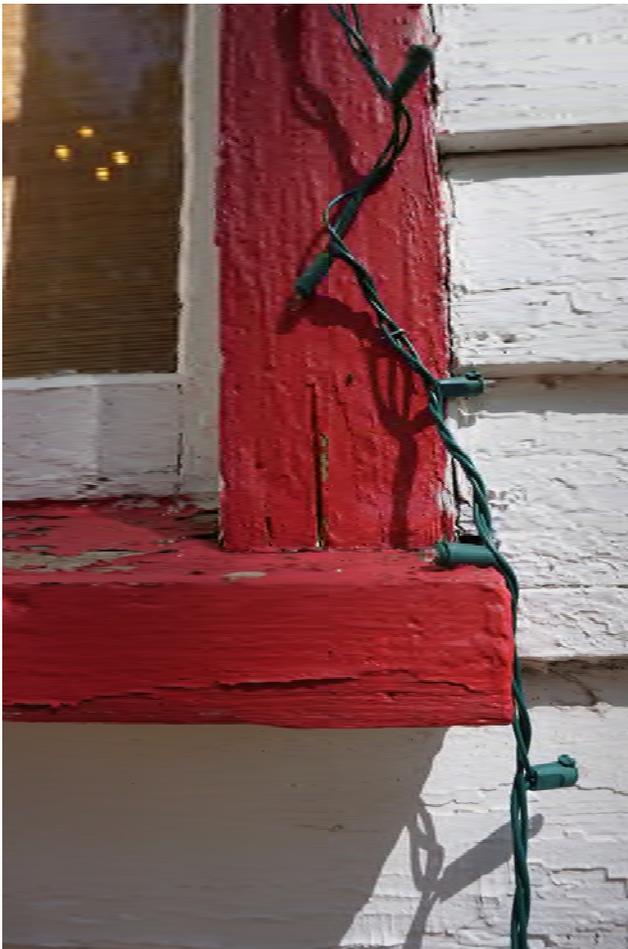
51.0 Split Wood and Peeling Paint

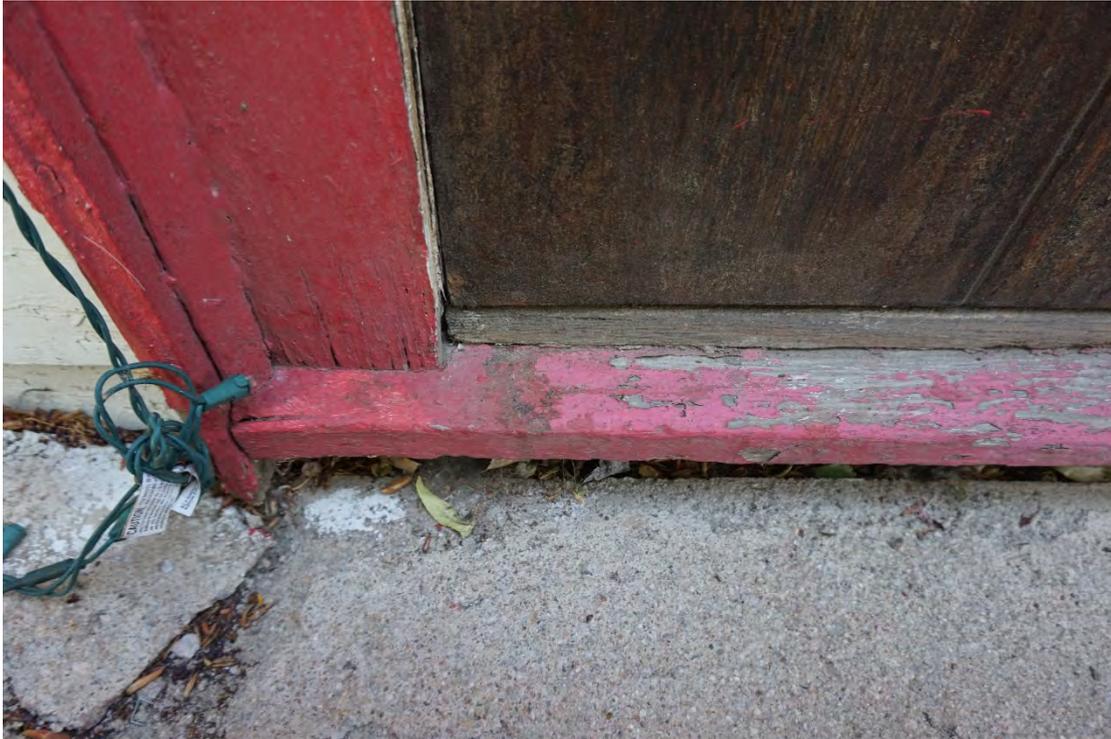
54.0 Deteriorated Sill at West Entrance

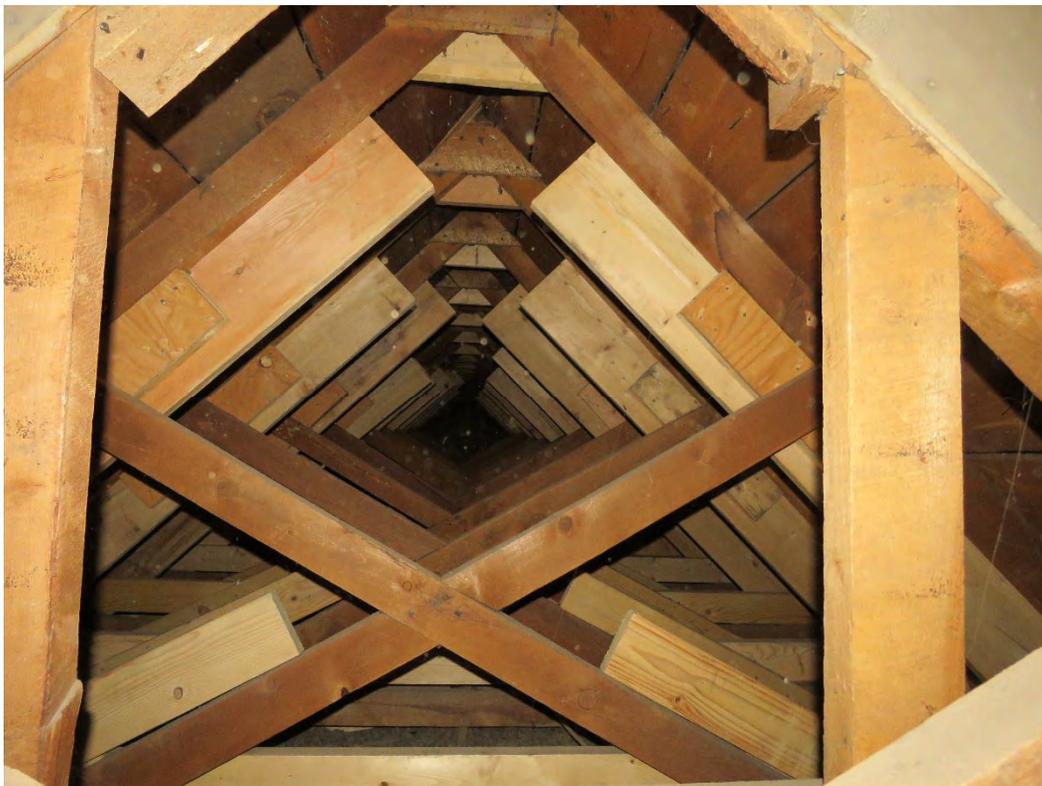
The roof framing system is in good condition. We did not observe any areas of deterioration or distress. The contemporary framing strengthening appears to have been added to address the bowing and deflections that can be seen in the roof from the ground.

67.0 Roof Trusses Over the Church Hall – Looking West – Note Additional Framing

The roof framing system appears to be stable and no work is recommended.

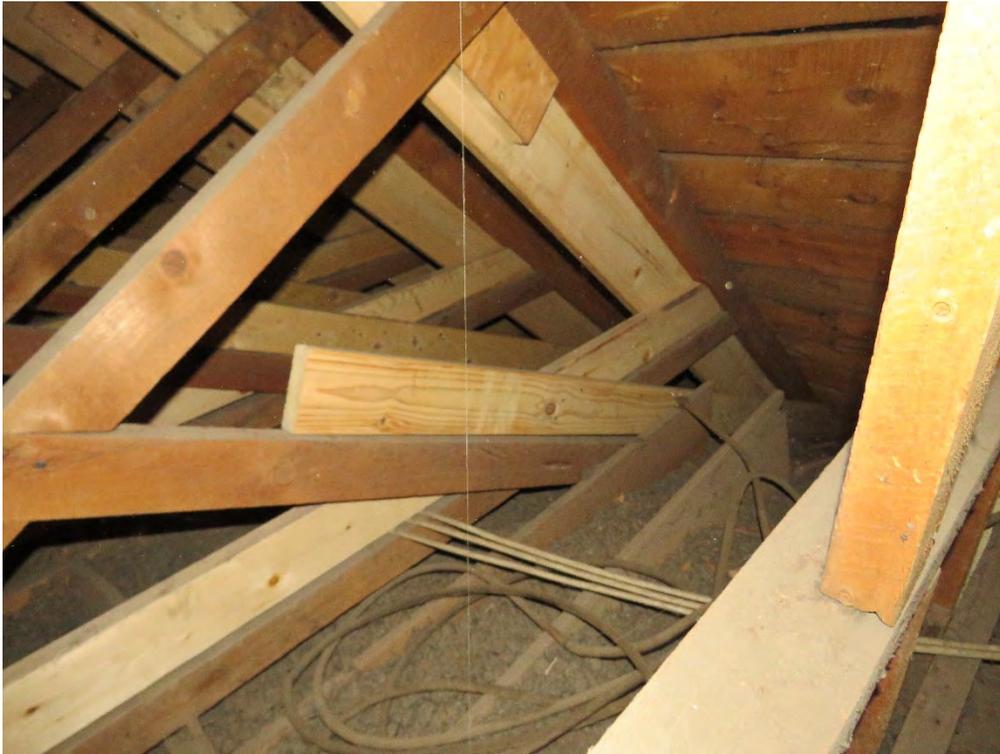
68.0 Roof Trusses with Additional Framing
