Above the Flood: Elevating Your Floodprone House

FEMA 347 / May 2000

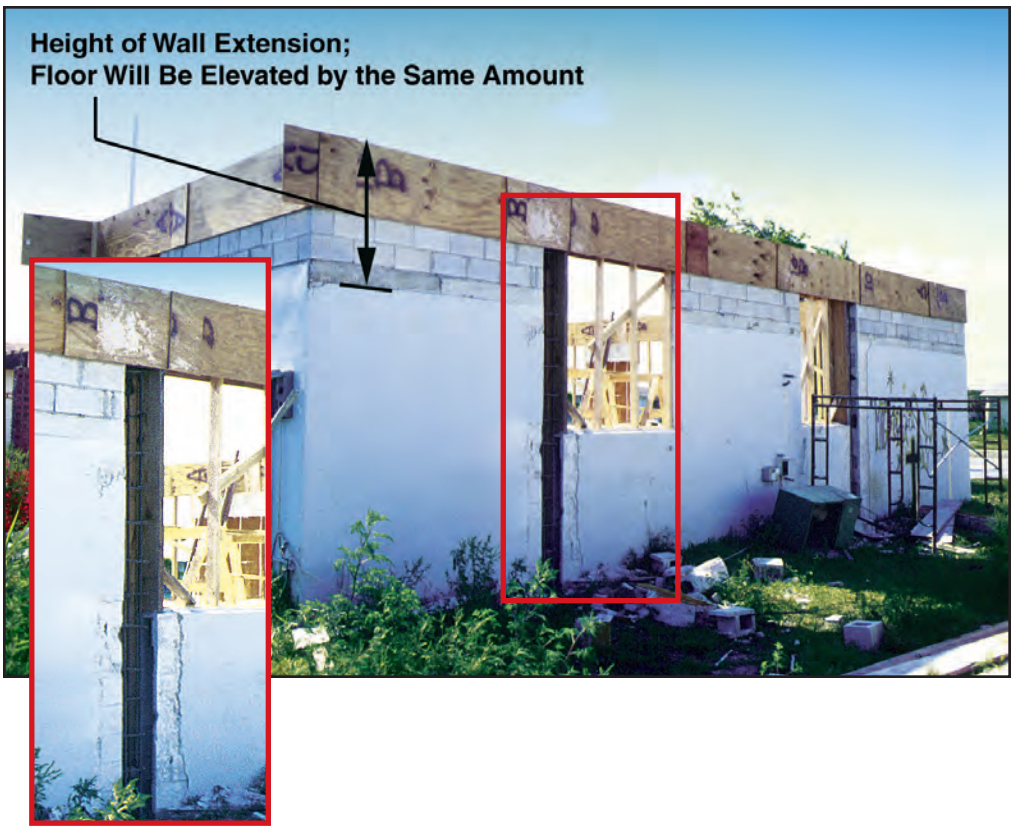
Figure 24
Another view of the extended walls. The vertical cuts in the walls next to the windows are for concrete tiedown columns that will be cast in place to further strengthen the extended walls against wind loads. The owner of this house was able to meet the elevation requirement by raising the floor only a few feet, as indicated by the amount that the walls have been extended.

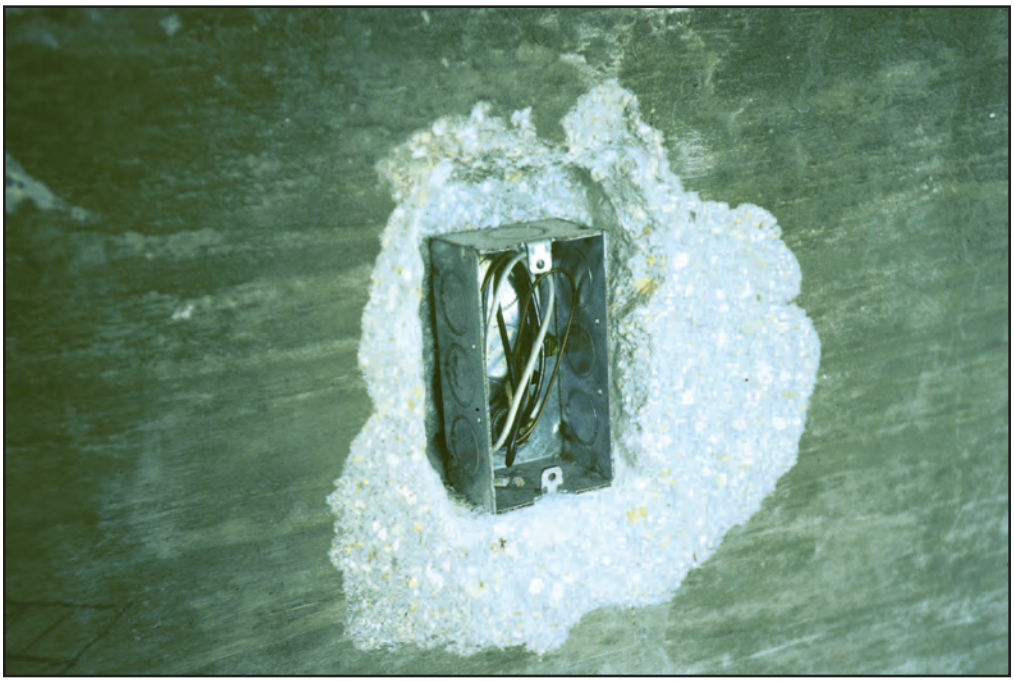
Figure 35
The electrical system is upgraded to meet current code requirements.

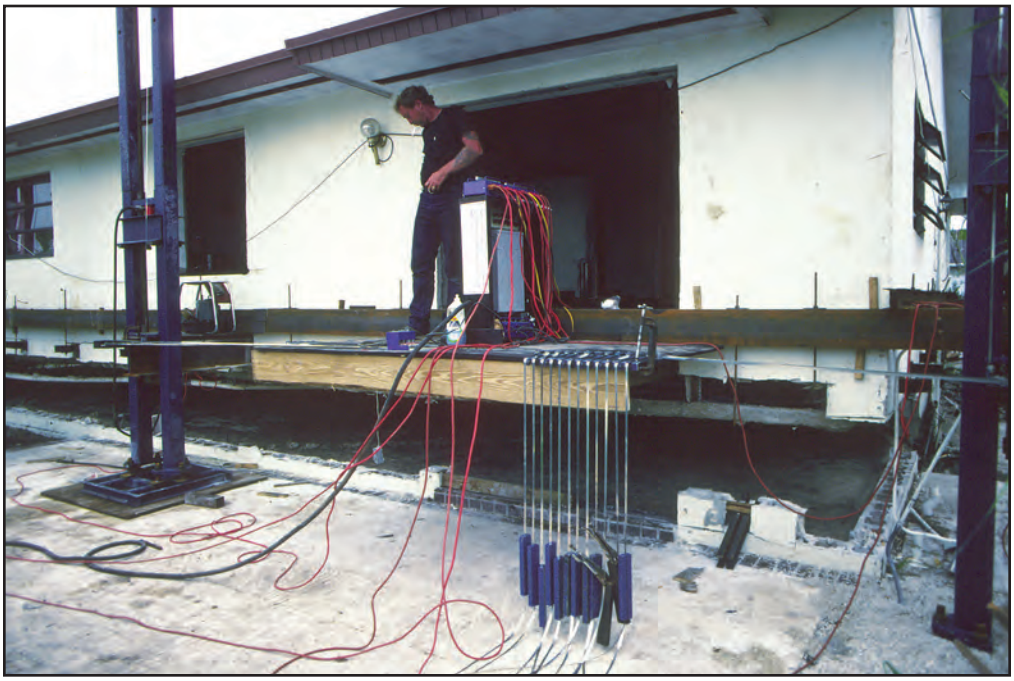
Figure 80
Lifting the house, while simple in theory, is complicated by the need to ensure an equal amount of lift at each jack throughout the process. Too much or too little lift at even one jack can cause the slab and walls to crack. The elevation contractor for this project used a sophisticated jacking system that provided the required level of control.
