St. Rose of Lima Catholic Church/Chamber of Commerce

HISTORIC STRUCTURE ASSESSMENT

SHF PROJECT NUMBER 2018-HA-020

FINAL HISTORIC STRUCTURE ASSESSMENT – DELIVERABLE #5

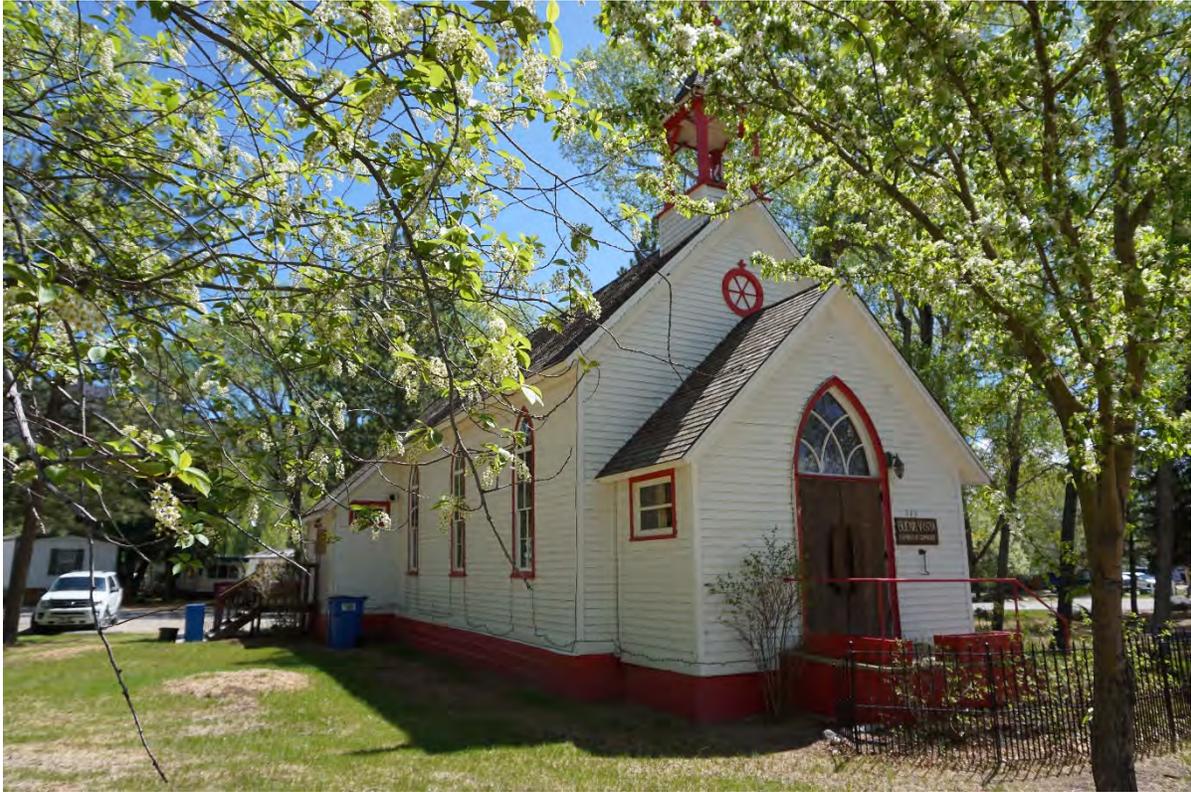
1.0 Looking East – Front Facade

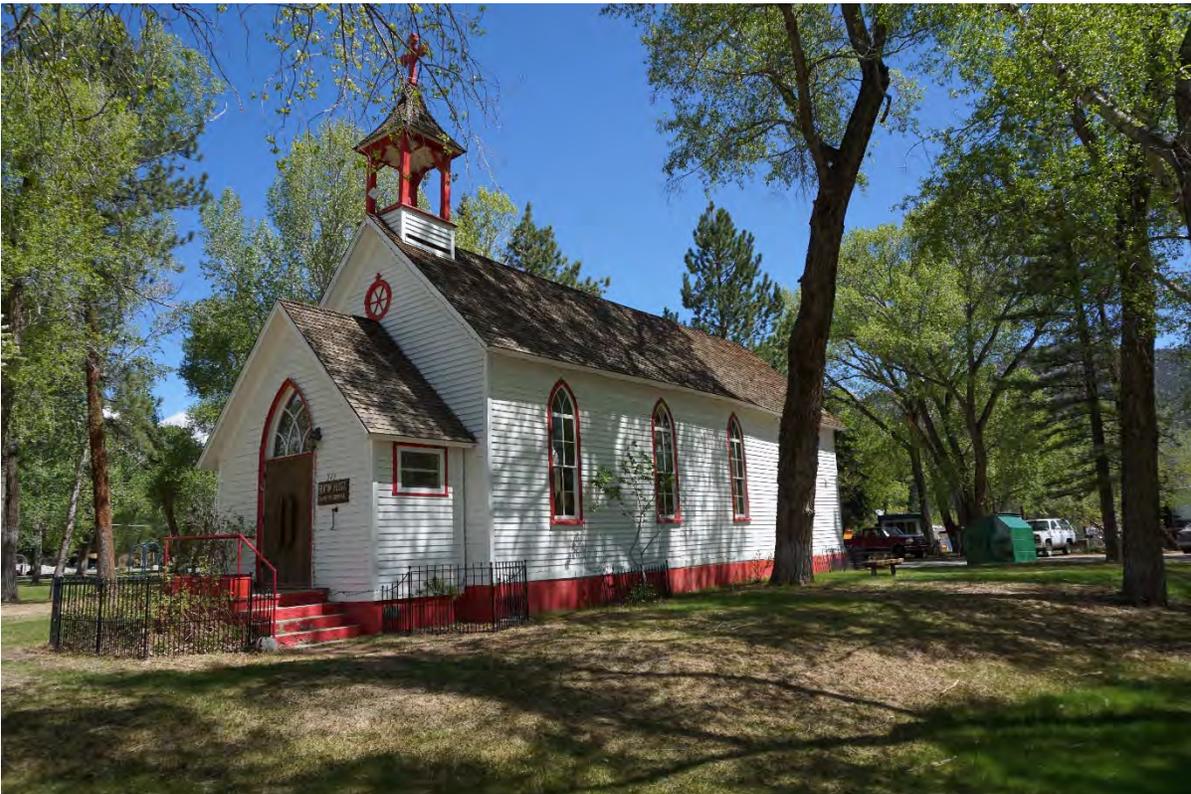
2.0 Looking Northeast

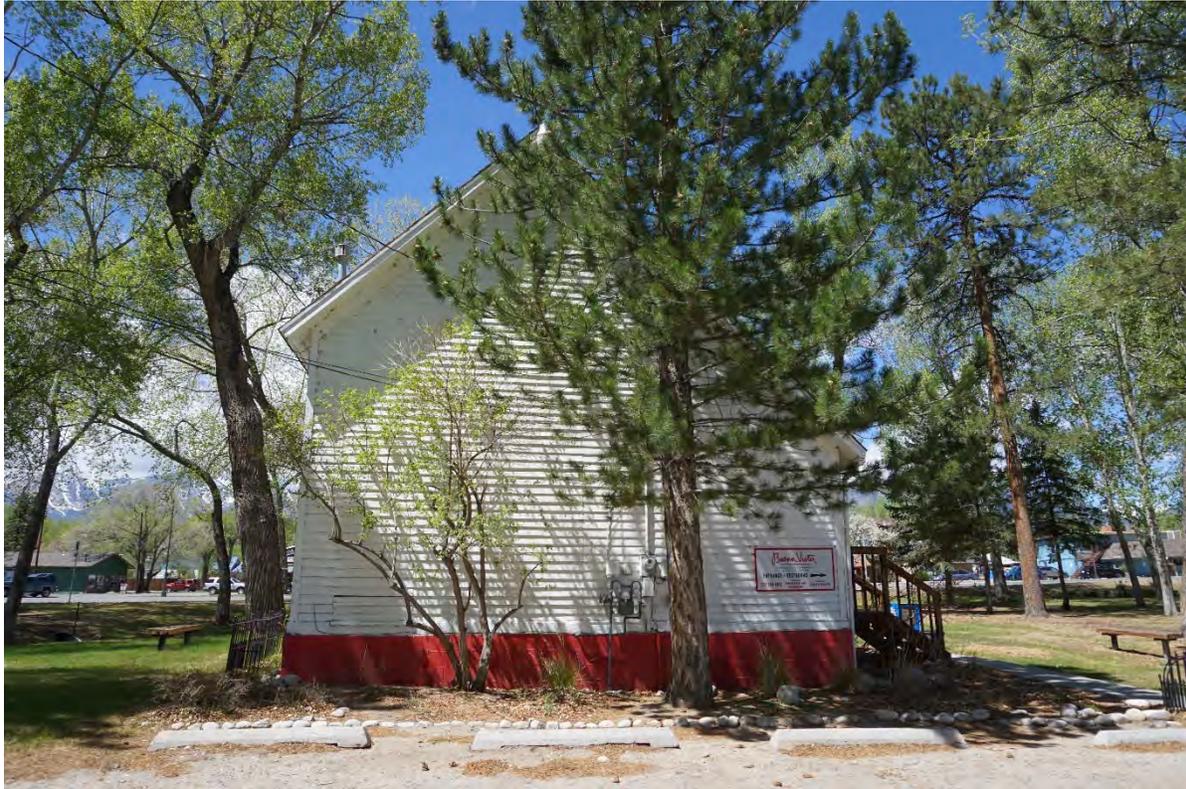
3.0 Rear Elevation – Looking West

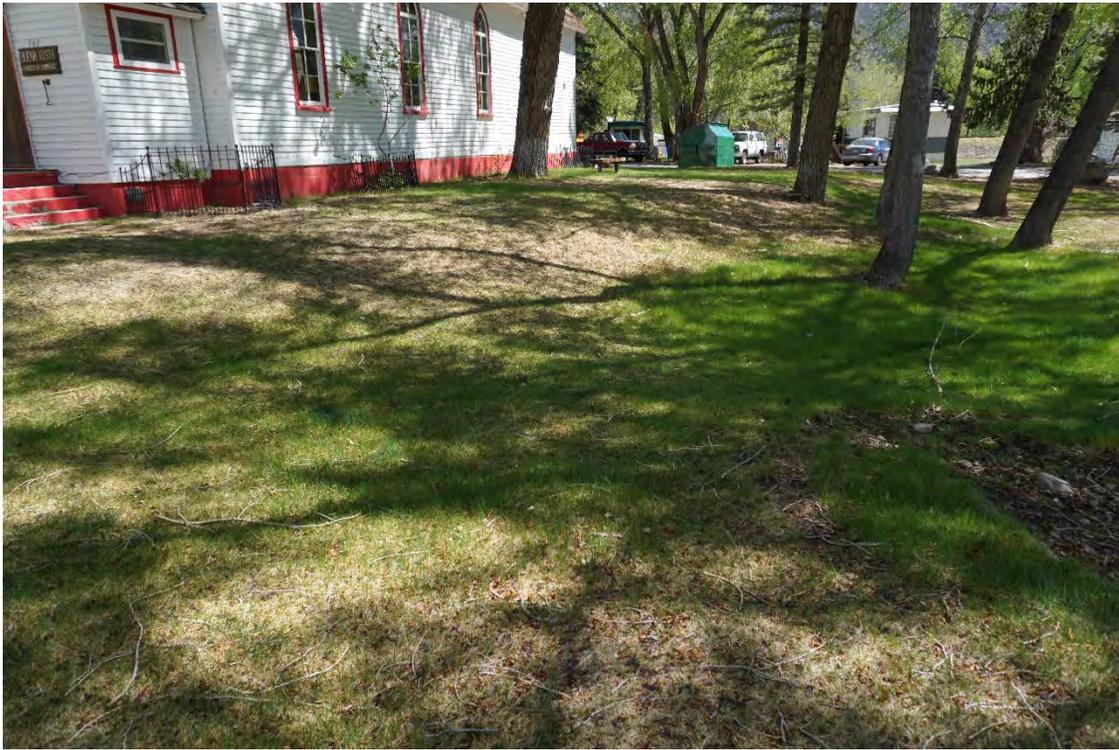
5.0 Green Area is the Drainage Swale at the South Elevation

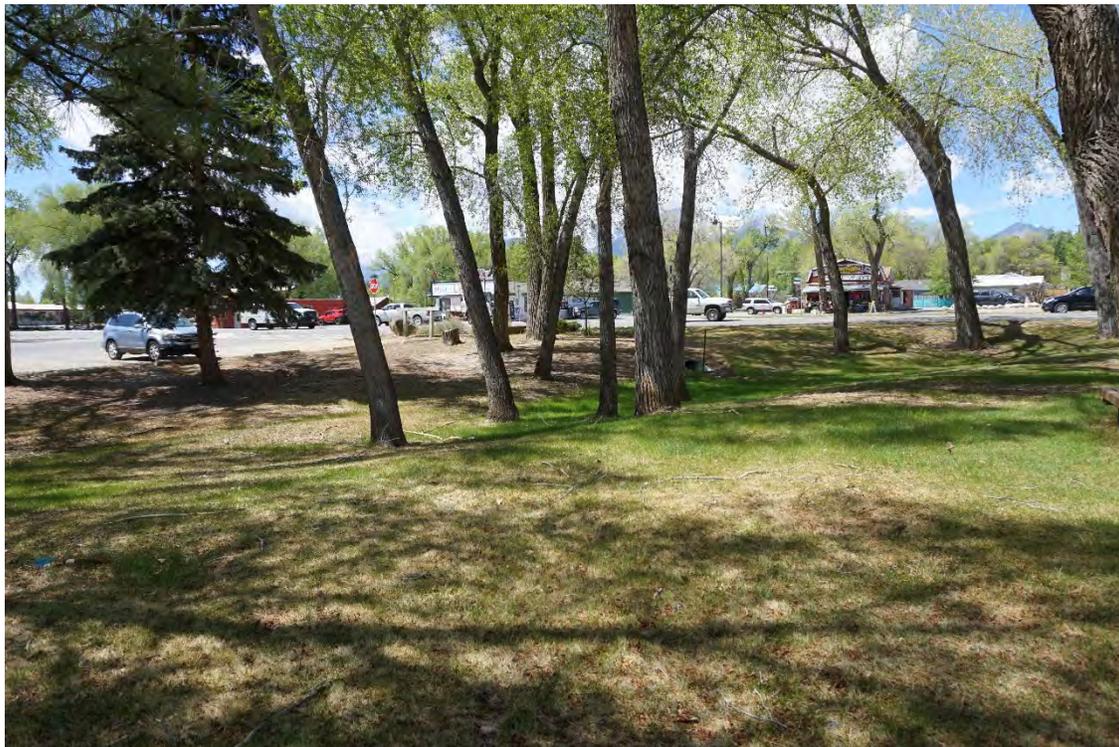
6.0 Drainage Swale – Looking West

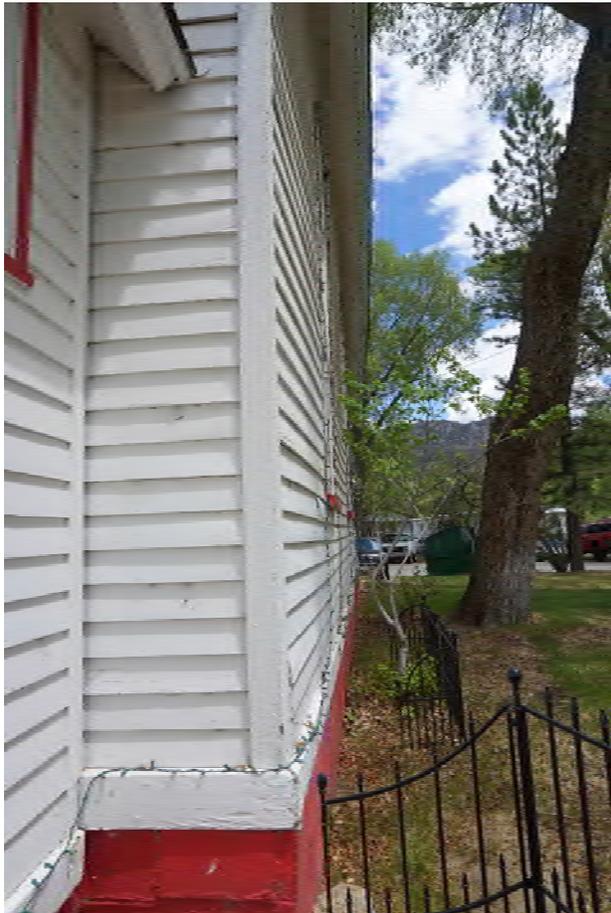
8.0 South Elevation – Planting Beds with Bushes at Base of Building. Note the Upper Wall Leaning Outward

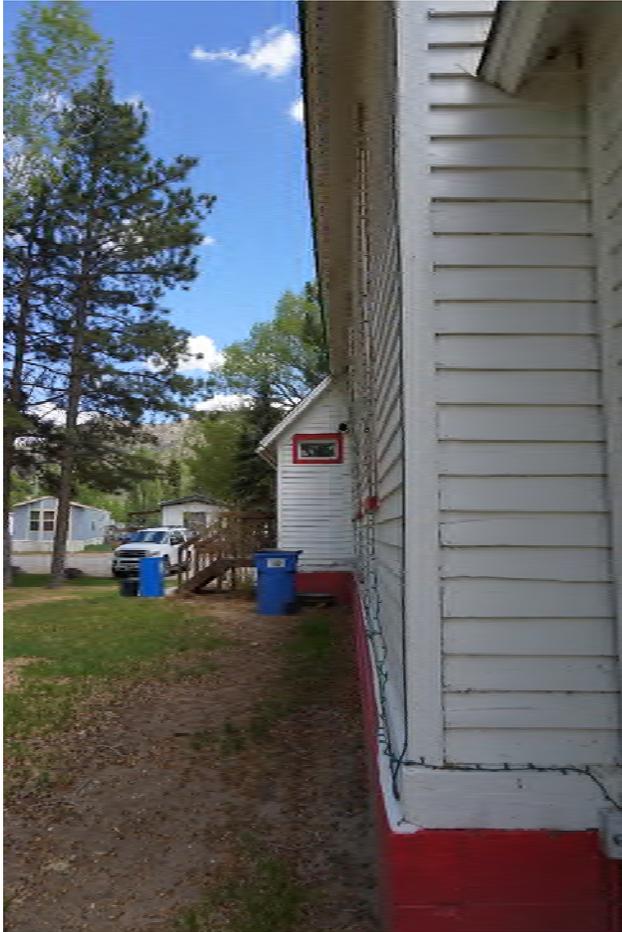
9.0 North Elevation of Building – Note Upper Wall Leaning Outward

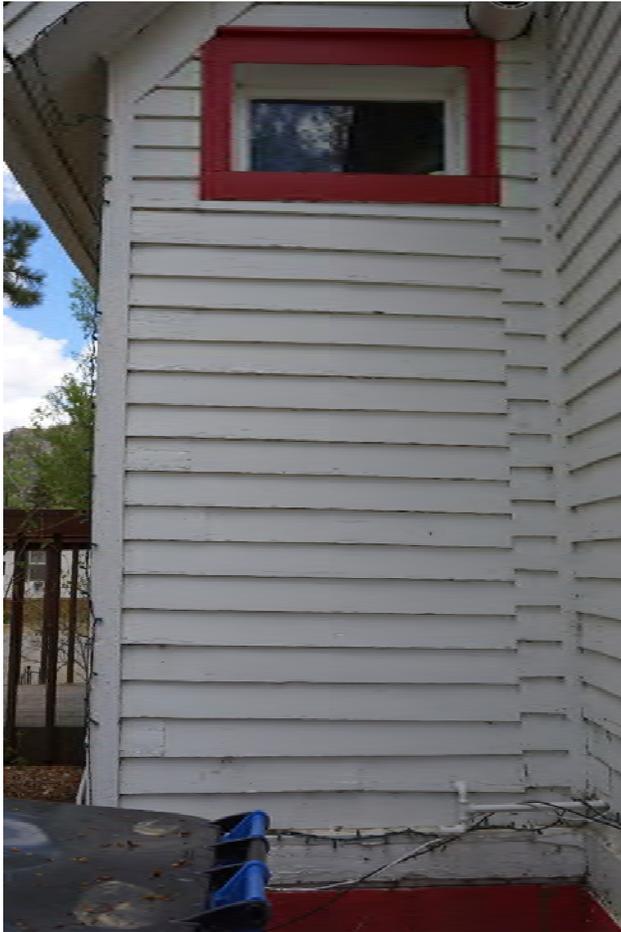
13.0 Restroom Addition – Looking East. Line in Siding is a Result of the Chimney Removal

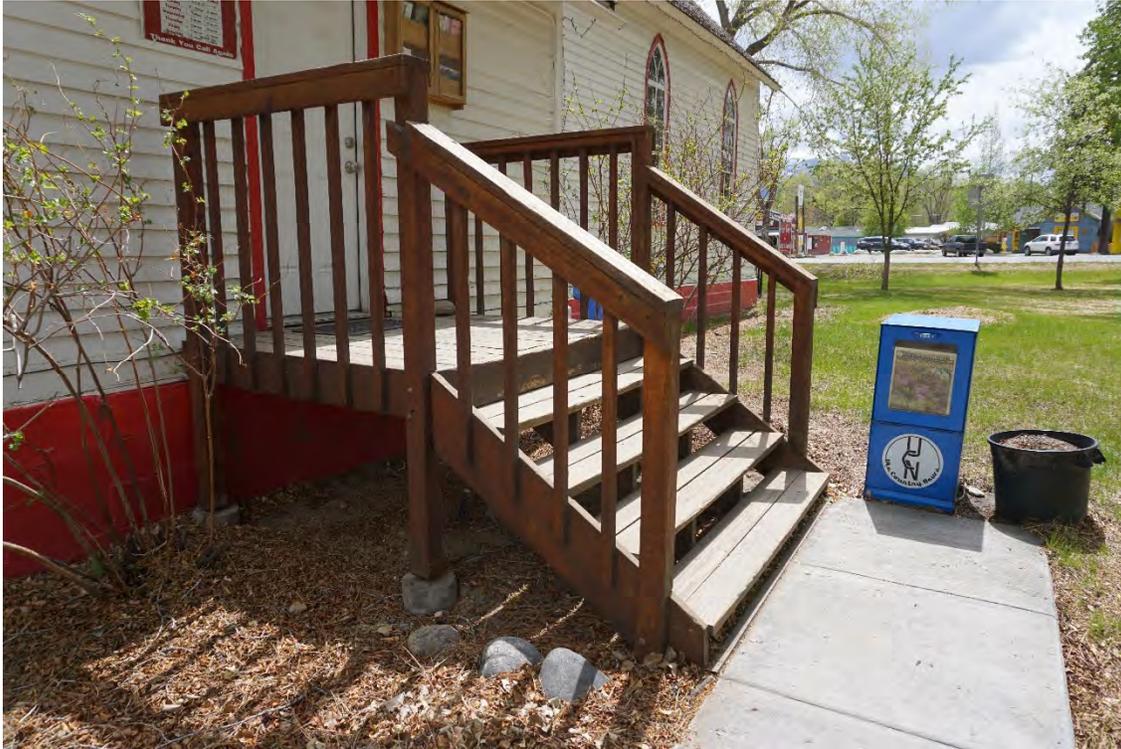
15.0 Entrance Stair at Rear Entrance

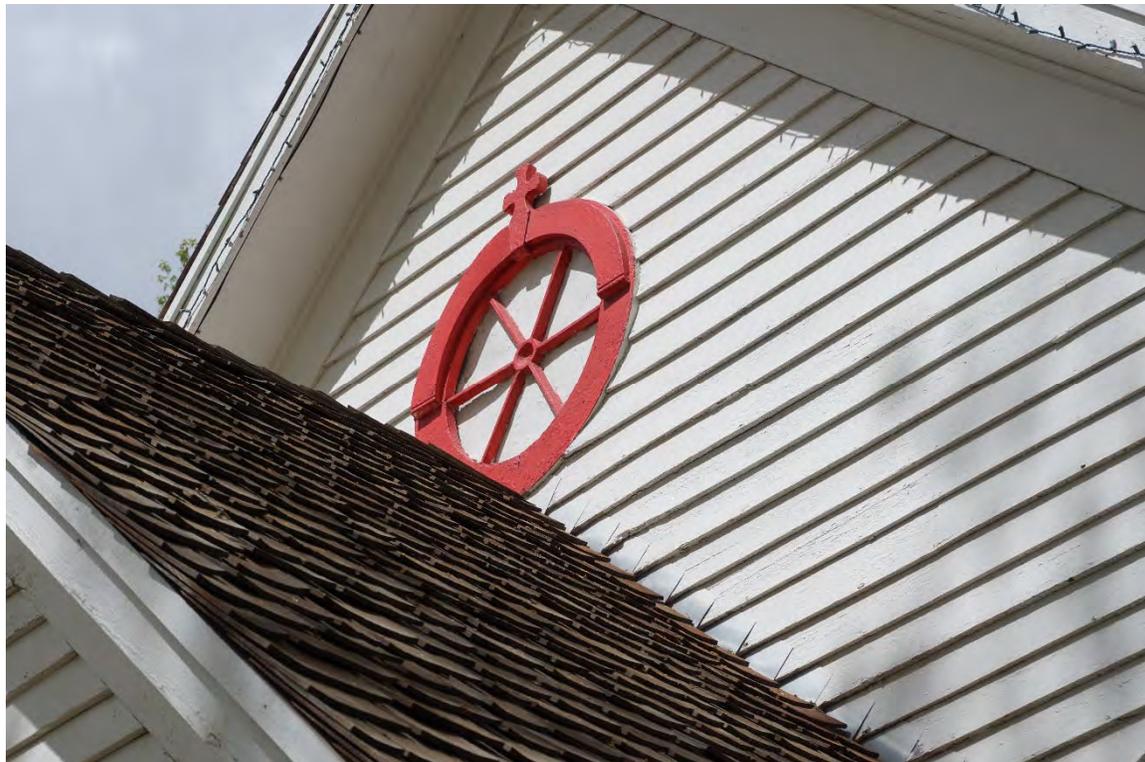
24.0 Ocular Window Above Entrance Vestibule at West Elevation

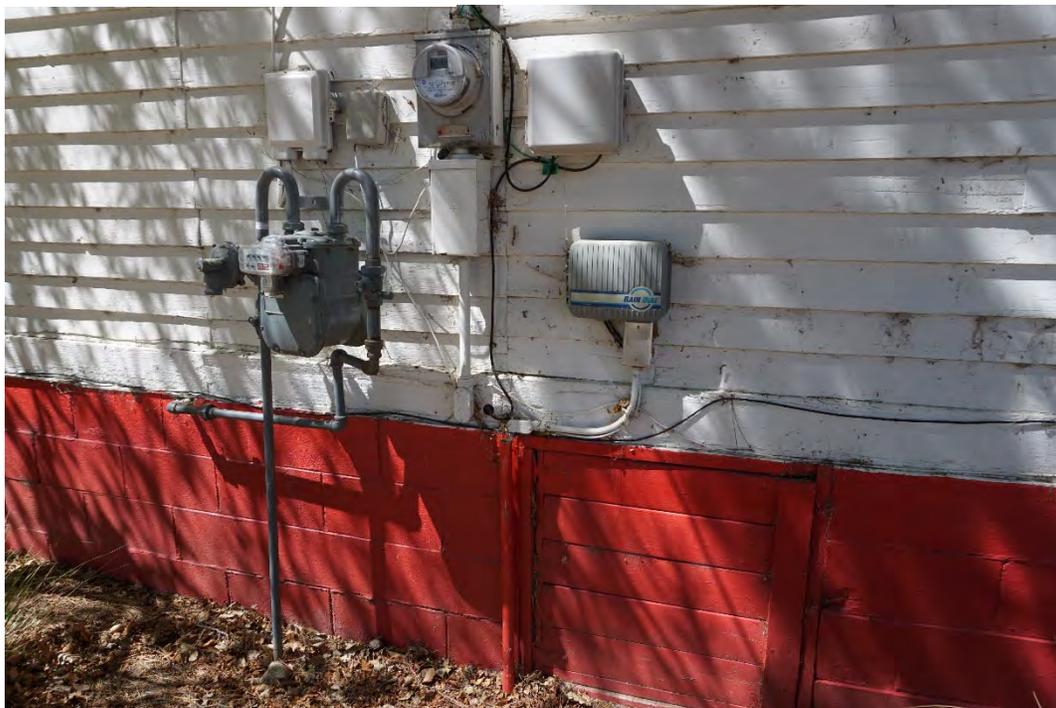
27.0 Gas Meter, Electrical Meter, Sprinkler Controller – East Elevation

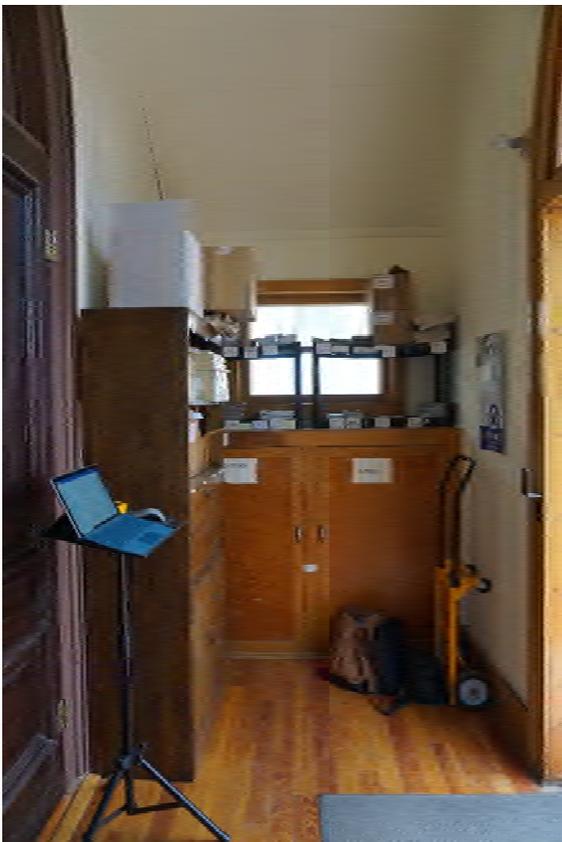
30.0 Vestibule – Looking South

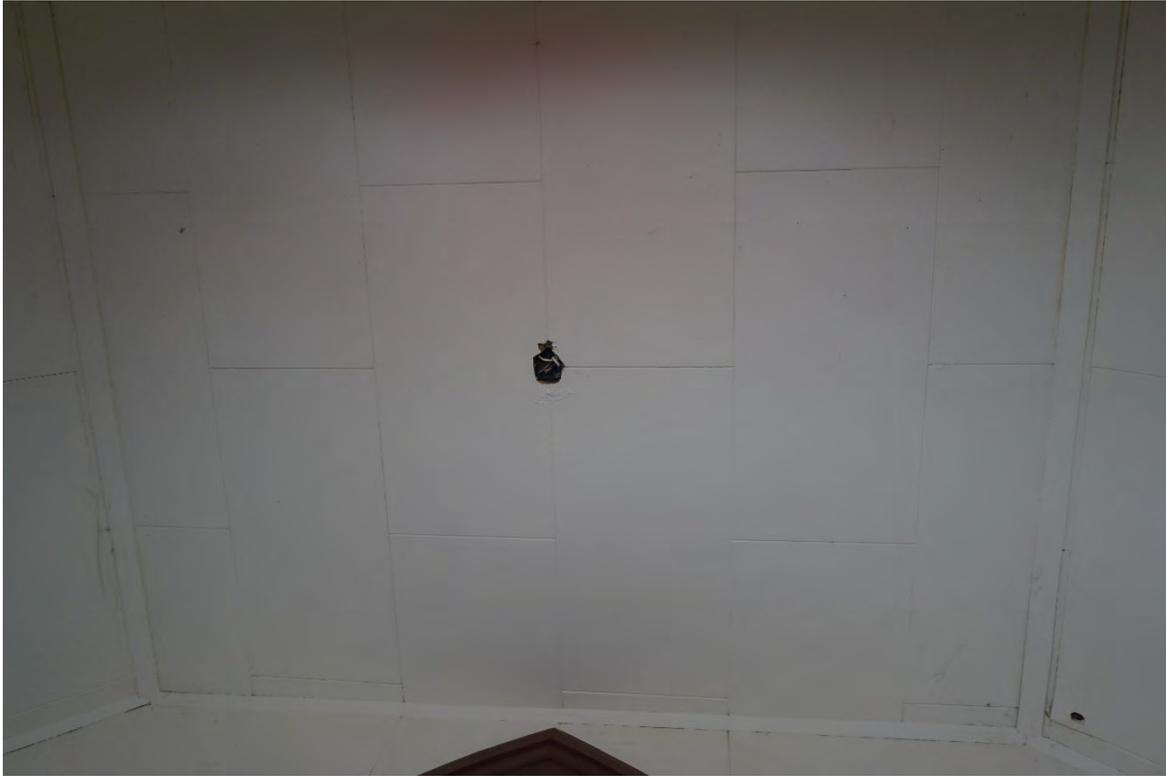
31.0 Location of Historic Light Fixture

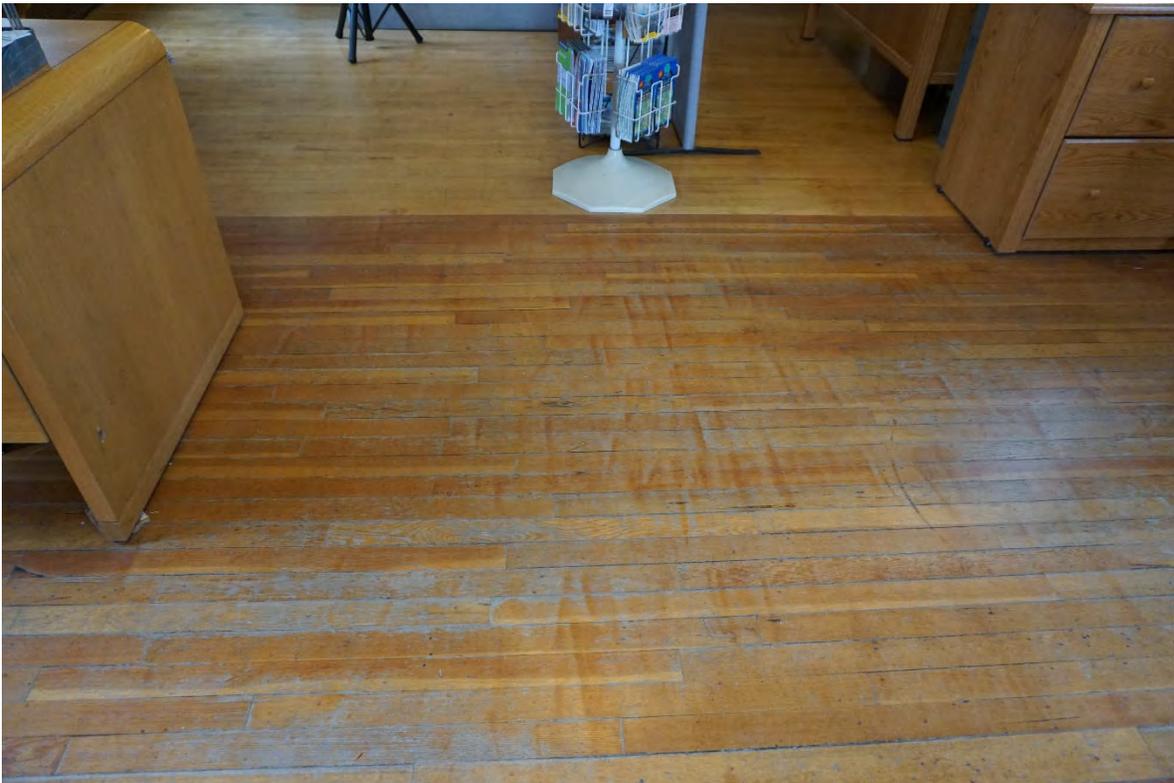
32.0 Wood Flooring

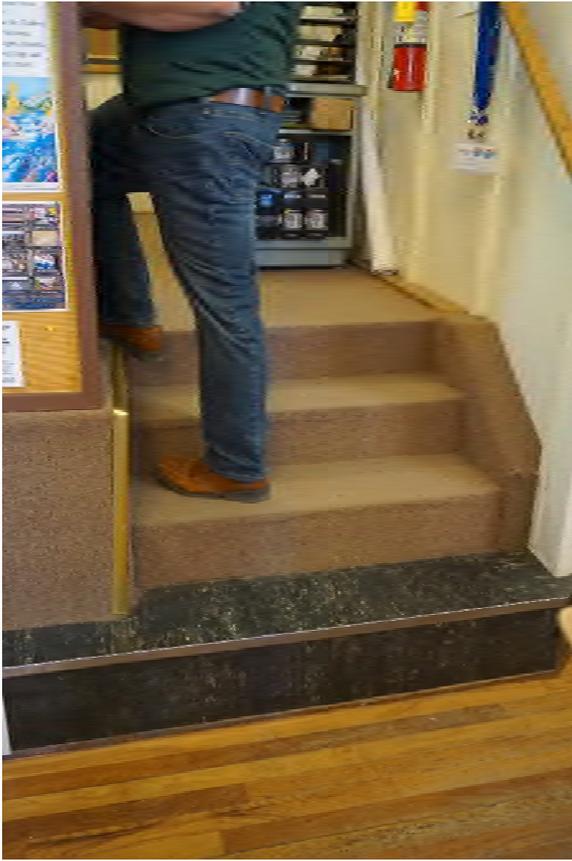
33.0 Steps to Chancel – Original Step is Dark Grey,
Other Steps Added after the Bldg. Was Moved

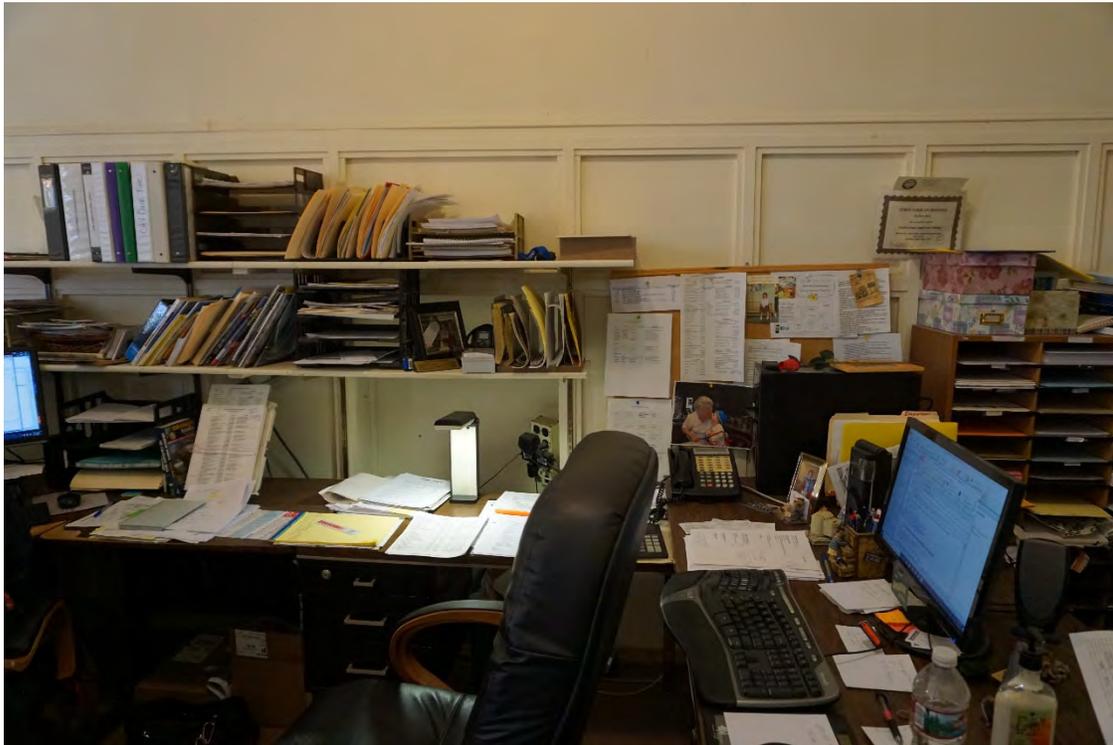
36.0 Chancel – Looking North. Historic Opening is Behind the Desk

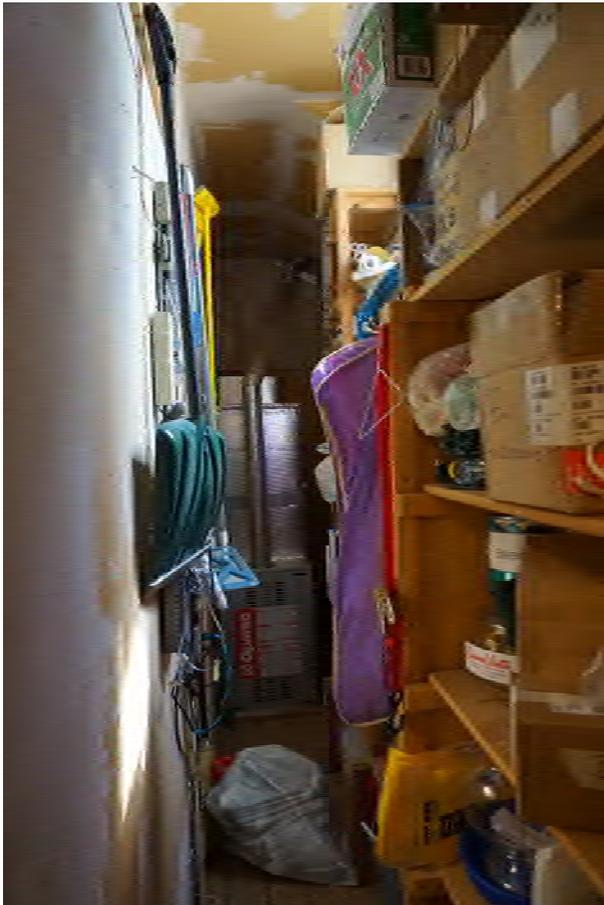
37.0 Storage Room – Looking East

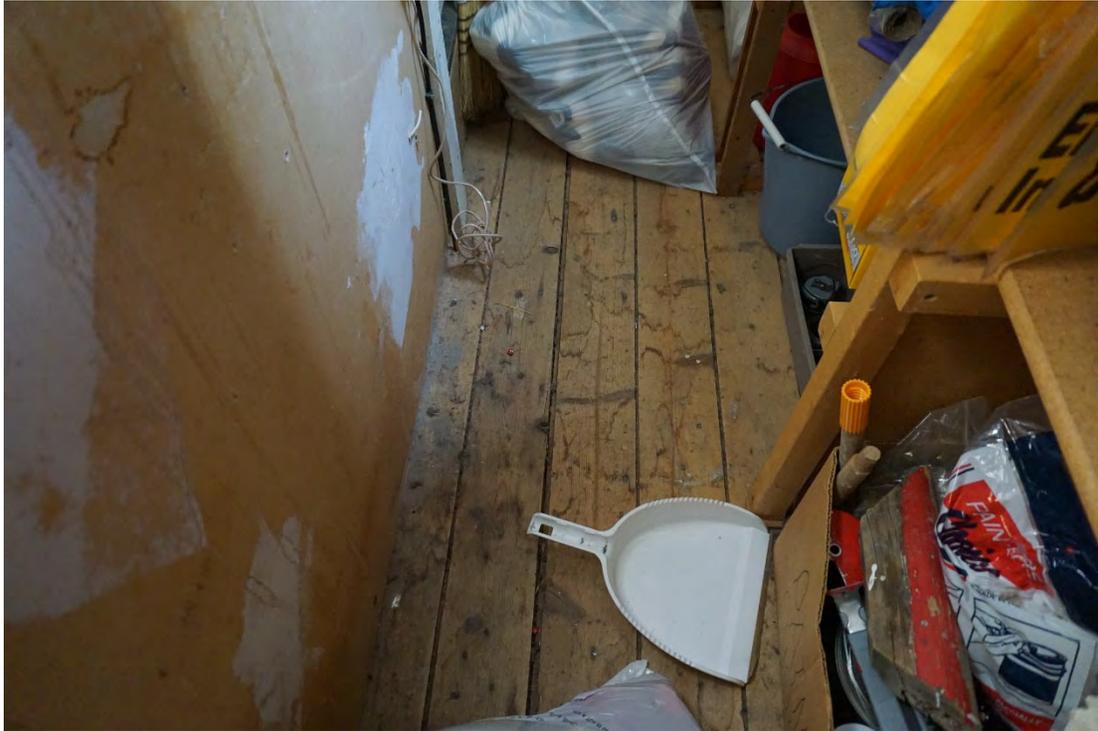
38.0 Floor of Storage Room

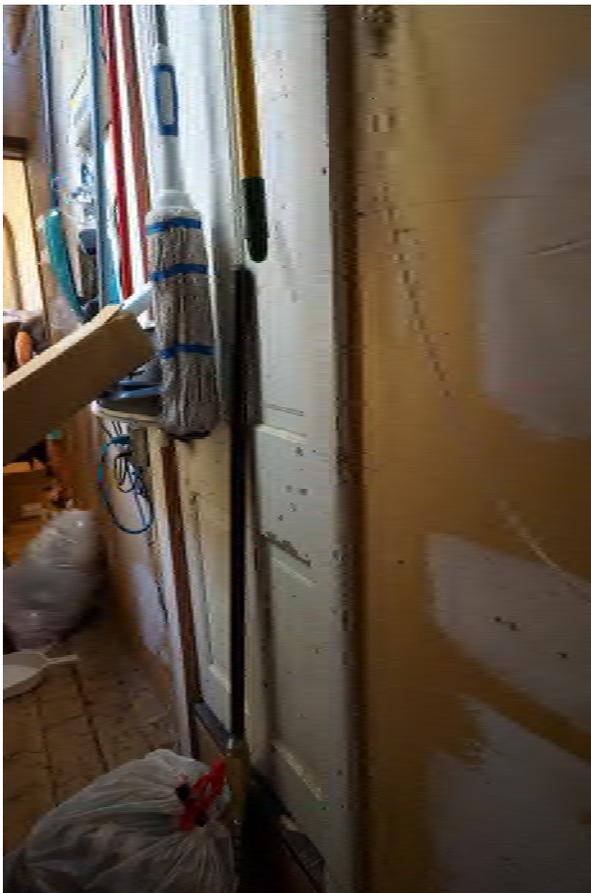
39.0 Historic Door in Storage Room – Led to Chancel, It is Now Blocked

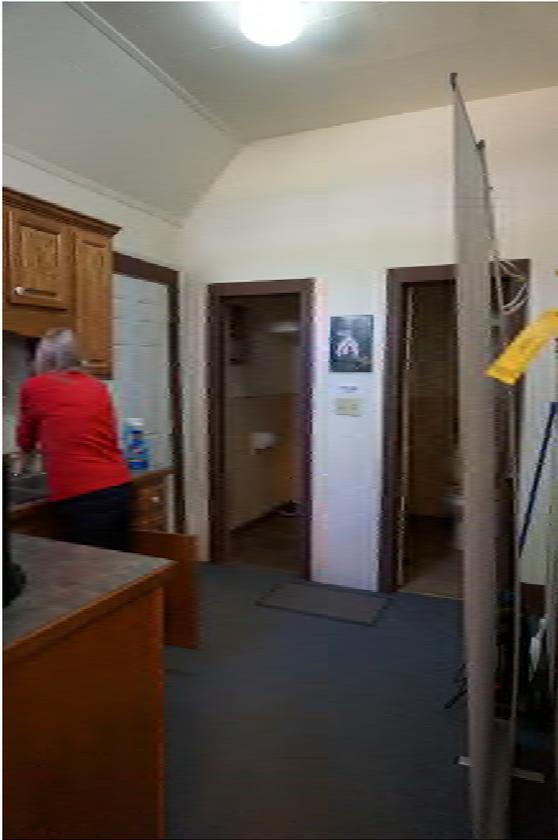
40.0 Restroom/Kitchenette Addition

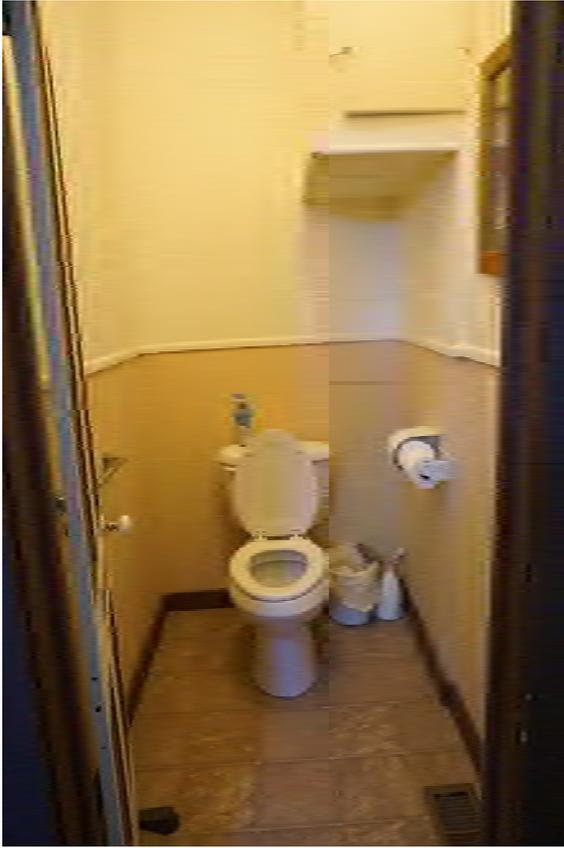
42.0 Restrooms

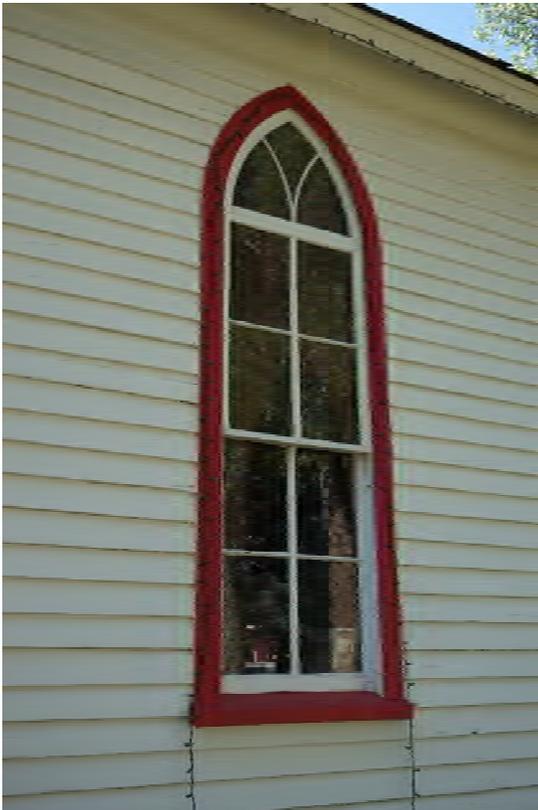
43.0 Typical Window

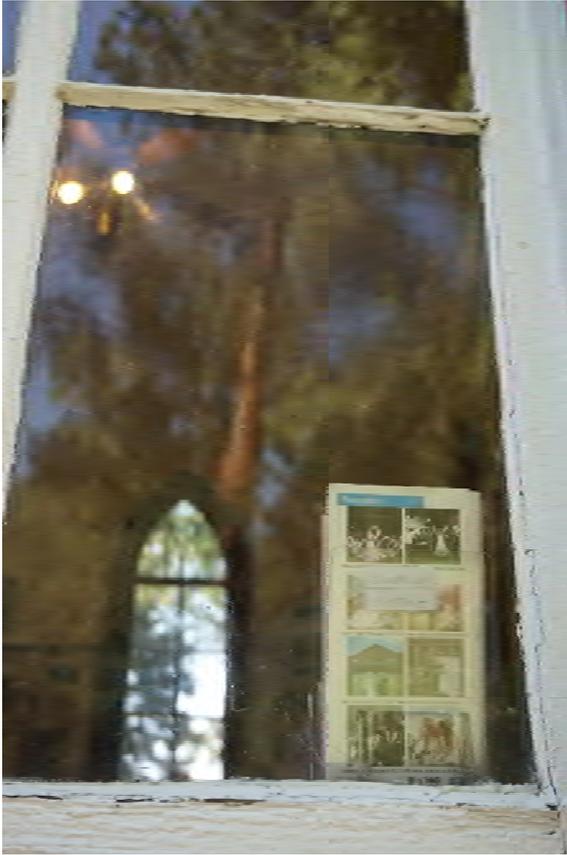
46.0 Poor Glazing Putty

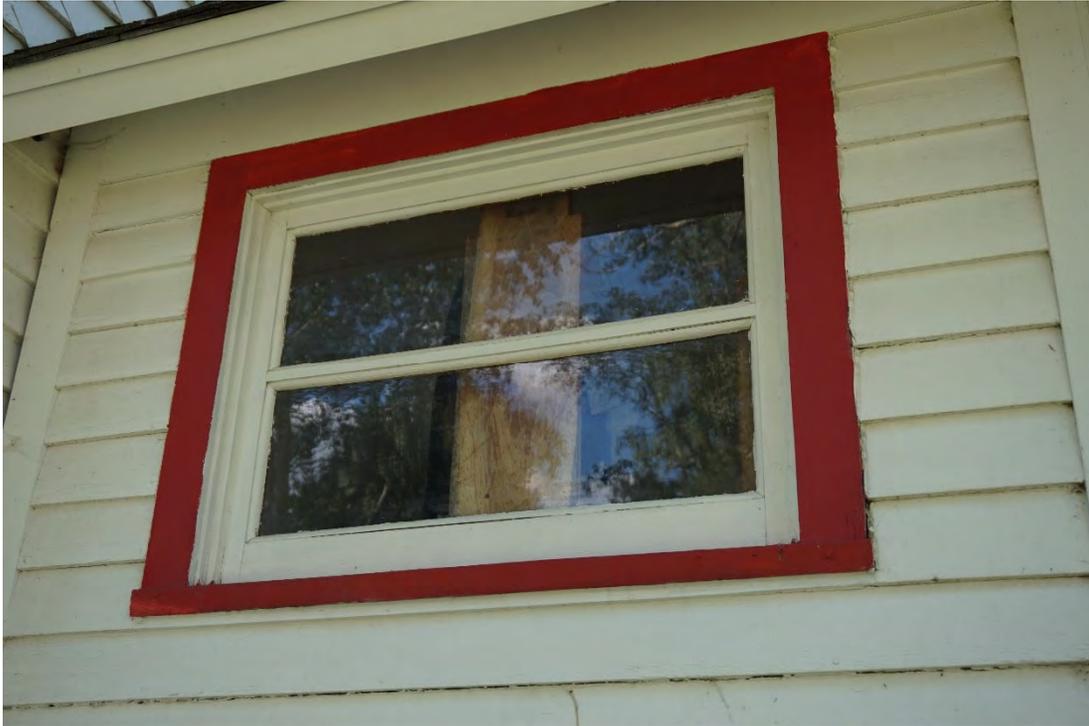
50.0 Vestibule Window

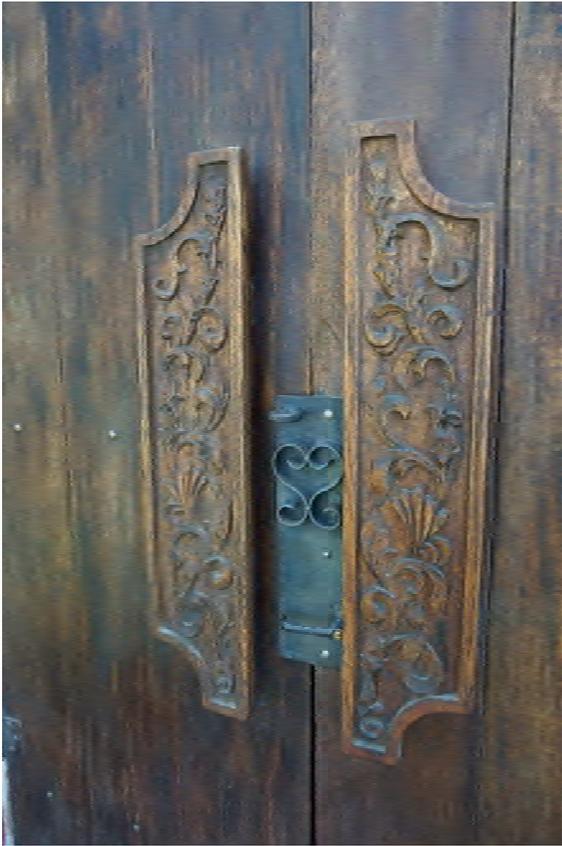
52.0 Door Hardware at West Entrance

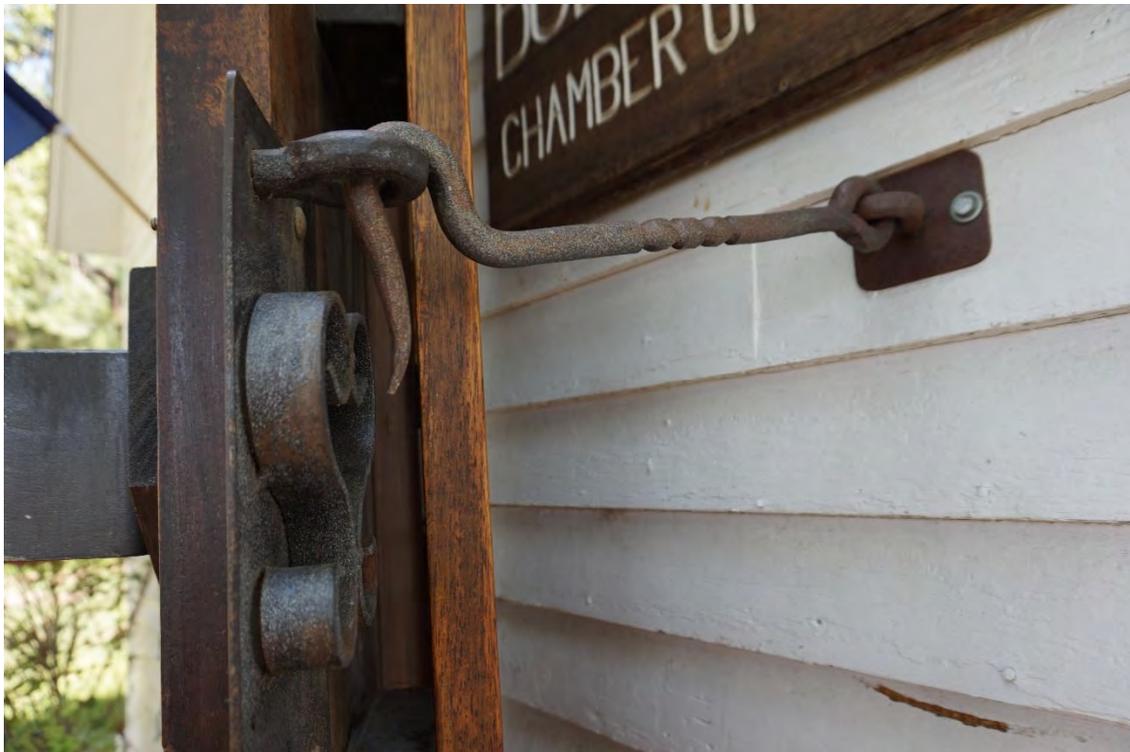
53.0 Door Hook at West Entrance

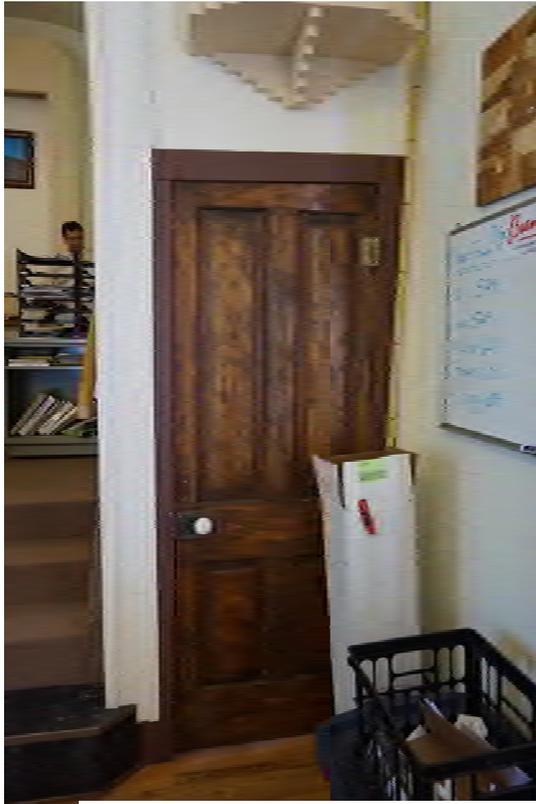
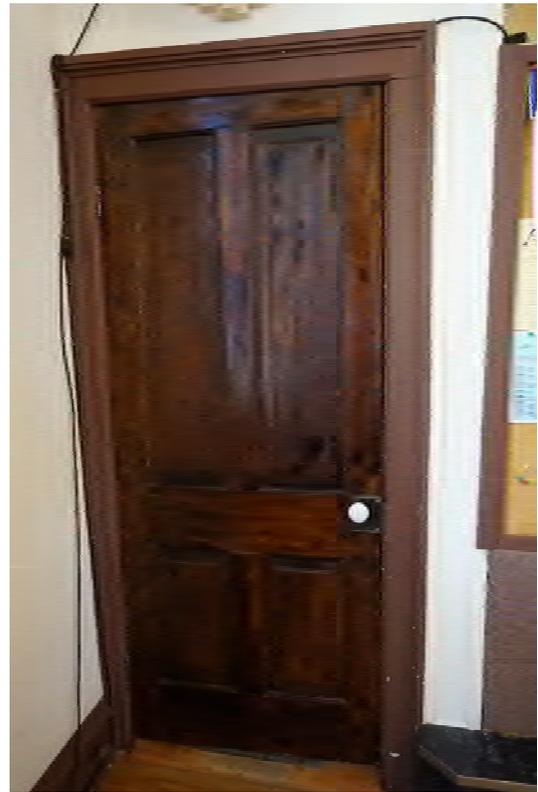
55.0 Doors Into the Storage Room and the Kitchen Addition – Paint was Removed By the Chamber to Restore the Doors

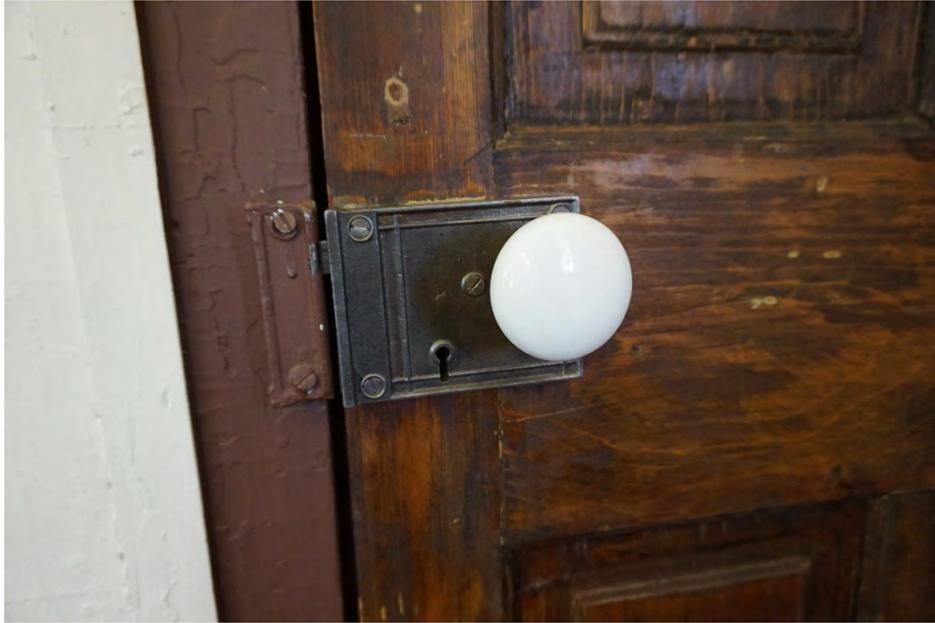
56.0 Rim Lock at Doors

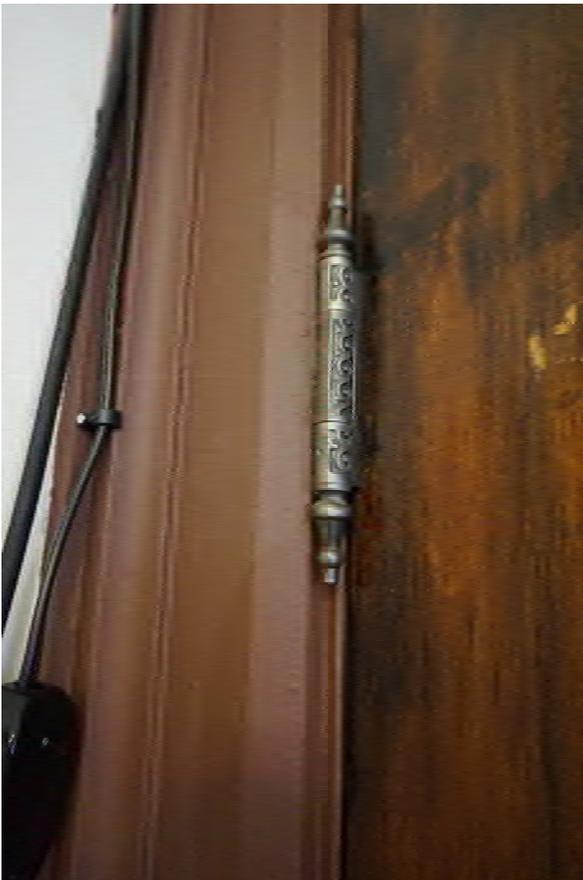
57.0 Typical Hinge at Doors

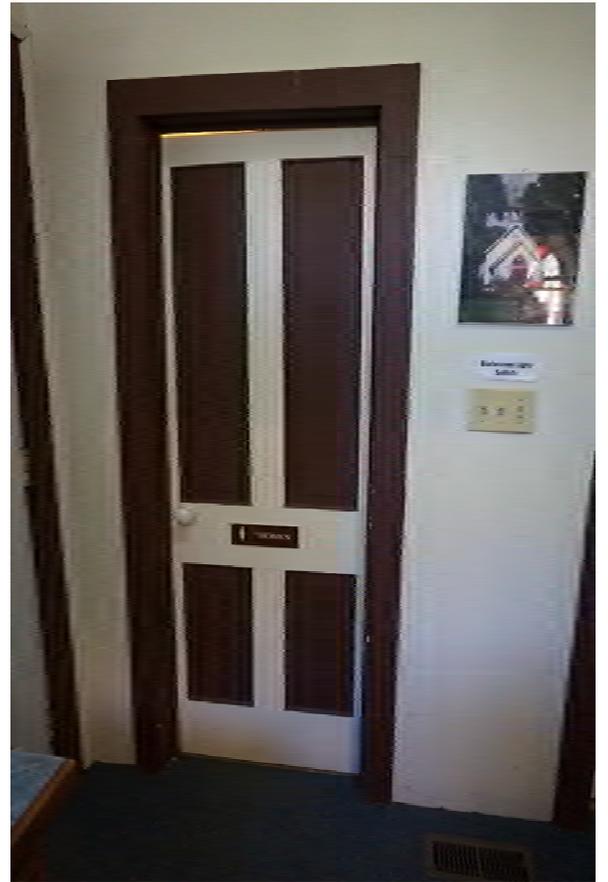
58.0 Typical Painted Door – Restroom Doors

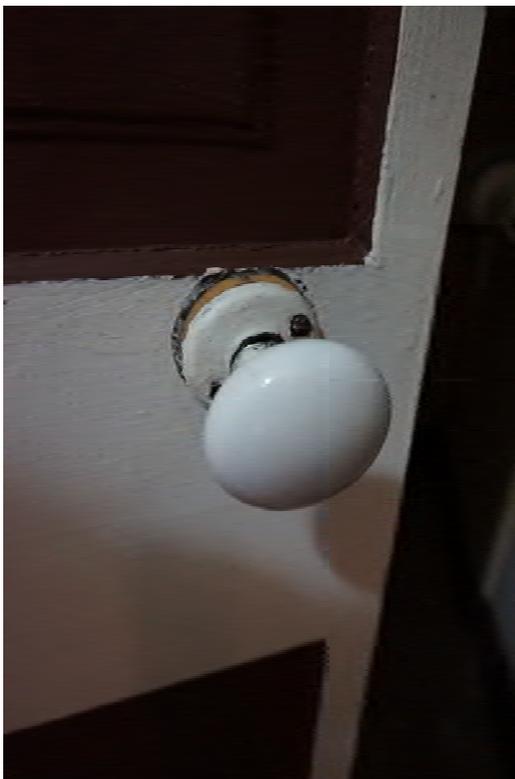
59.0 Rim Lock at Restroom Doors

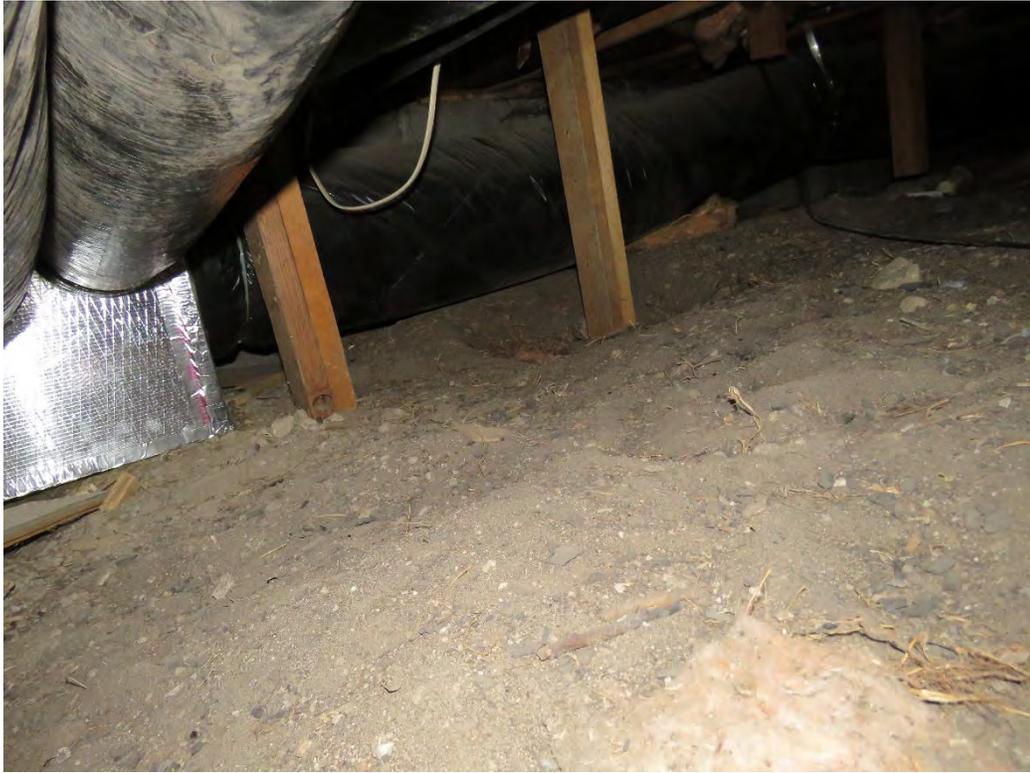
74.0 Crawlspace with Posts Coming Down to Footings

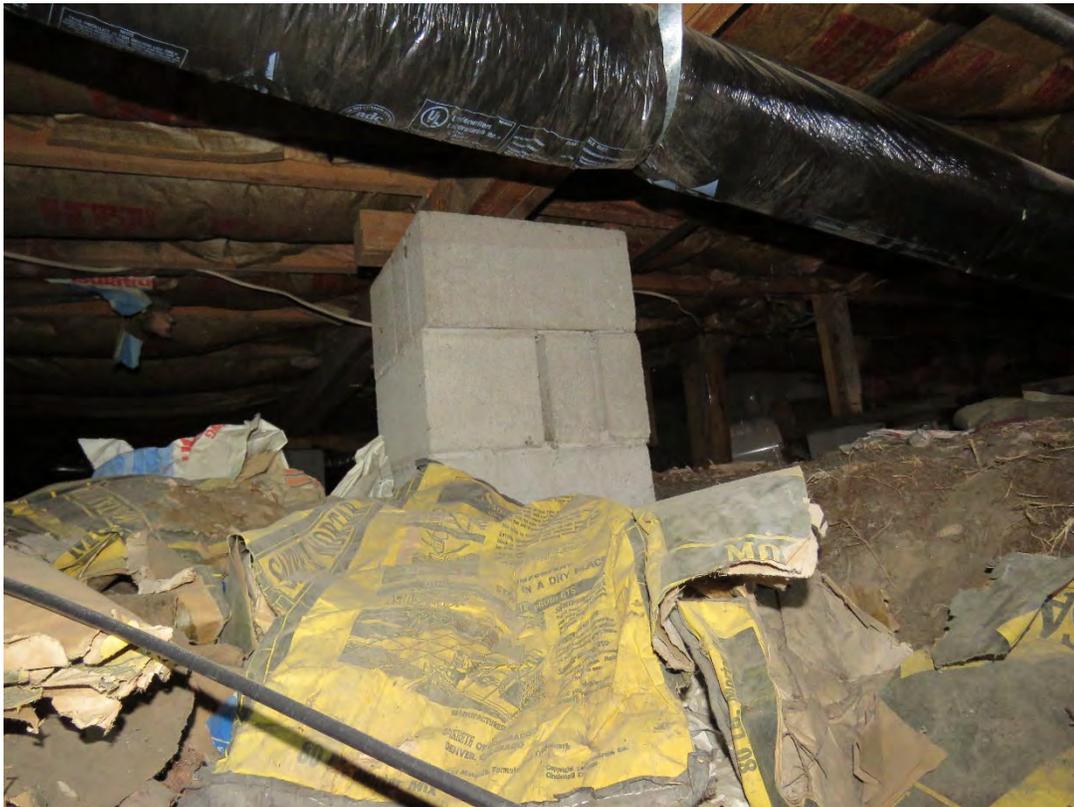
75.0 Concrete Block Pier

22. Repoint deteriorated and open mortar joints in the CMU foundation walls. Peeling paint should be scraped and the foundation walls repainted.	1	ea	\$ 5,000.00	\$ 5,000.00
SUBTOTAL CONSTRUCTION PROJECT COSTS				\$ 107,450.00
General Conditions (20%)	0.2			\$ 21,490.00
Bonding (3%)	0.03			\$ 3,223.50
Permits (5%)	0.05			\$ 5,372.50
Overhead and Profit (20%)	0.2			\$ 27,507.20
SUBTOTAL CONSTRUCTION PROJECT COSTS				\$ 165,043.20
Architectural/Engineering Fees (6%)	0.06			\$ 9,902.59
SUBTOTAL PROJECT COSTS				\$ 174,945.79
Contingency (15%)	0.15			\$ 26,241.87
TOTAL PROJECT COSTS				\$ 201,187.66
