St. Rose of Lima Catholic Church/Chamber of Commerce

HISTORIC STRUCTURE ASSESSMENT

SHF PROJECT NUMBER 2018-HA-020

FINAL HISTORIC STRUCTURE ASSESSMENT – DELIVERABLE #5

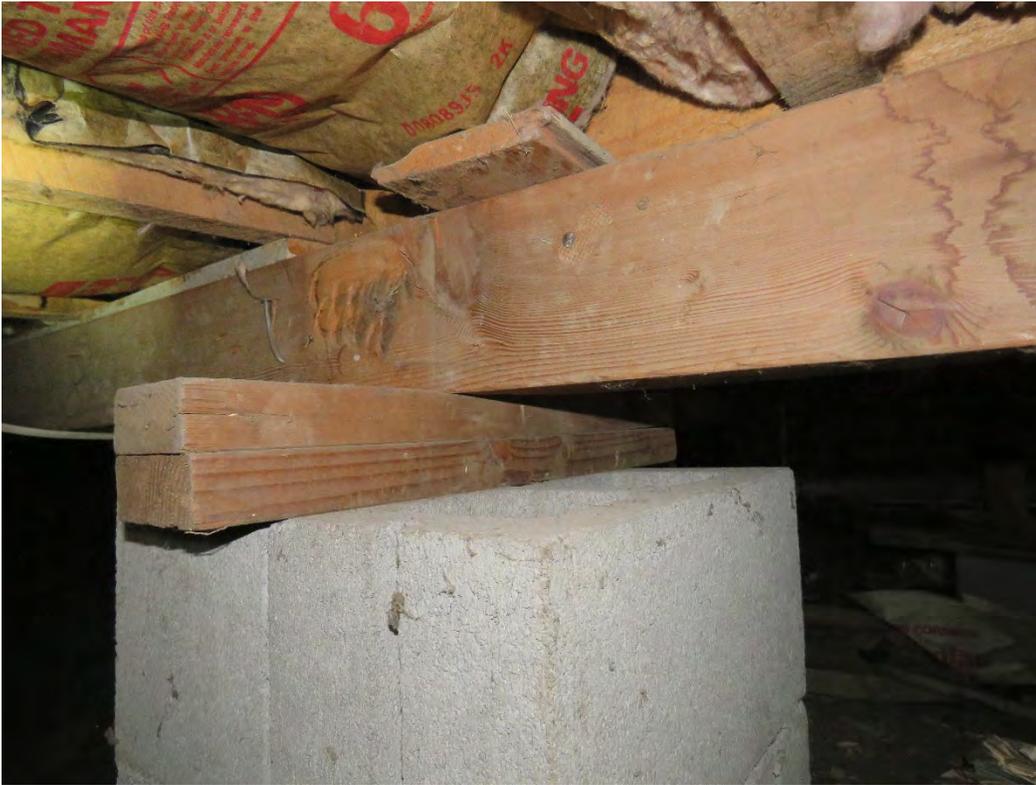
76.0 Concrete Block Pier – Supporting Beam

22. Repoint deteriorated and open mortar joints in the CMU foundation walls. Peeling paint should be scraped and the foundation walls repainted.	1	ea	\$ 5,000.00	\$ 5,000.00
SUBTOTAL CONSTRUCTION PROJECT COSTS				\$ 107,450.00
General Conditions (20%)	0.2			\$ 21,490.00
Bonding (3%)	0.03			\$ 3,223.50
Permits (5%)	0.05			\$ 5,372.50
Overhead and Profit (20%)	0.2			\$ 27,507.20
SUBTOTAL CONSTRUCTION PROJECT COSTS				\$ 165,043.20
Architectural/Engineering Fees (6%)	0.06			\$ 9,902.59
SUBTOTAL PROJECT COSTS				\$ 174,945.79
Contingency (15%)	0.15			\$ 26,241.87
TOTAL PROJECT COSTS				\$ 201,187.66

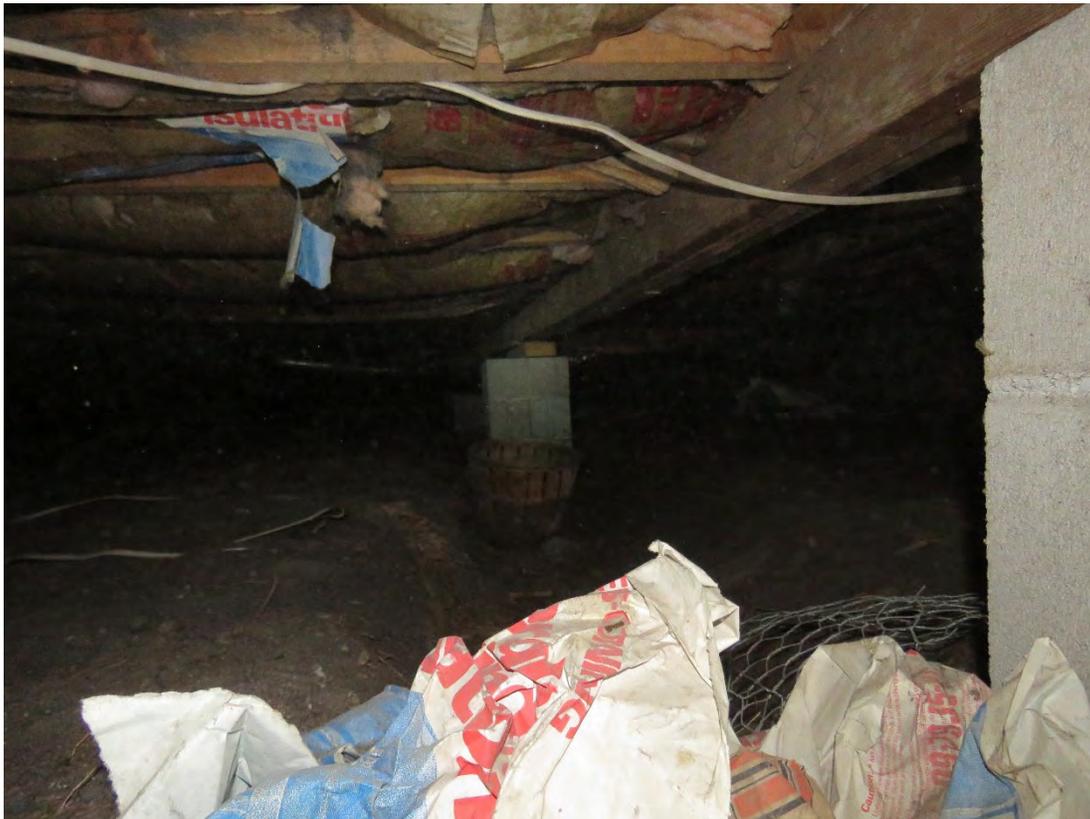
77.0 Row of Concrete Block Piers

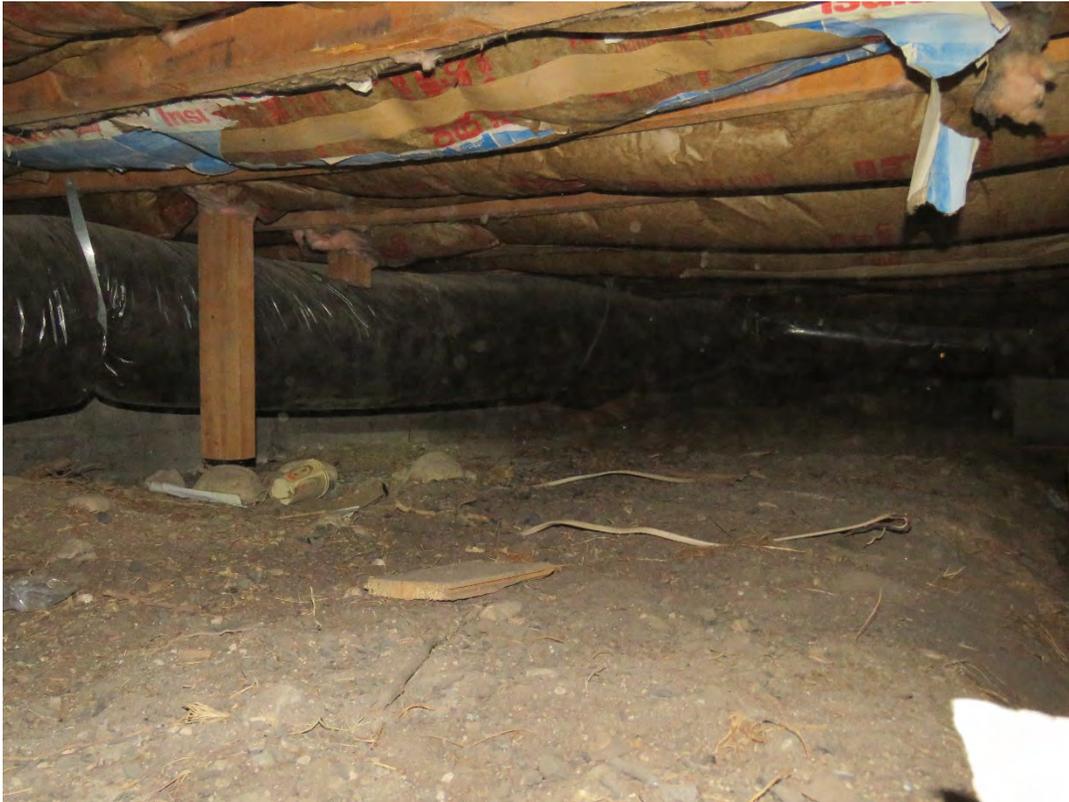
78.0 Post Coming Down to Prop Rock

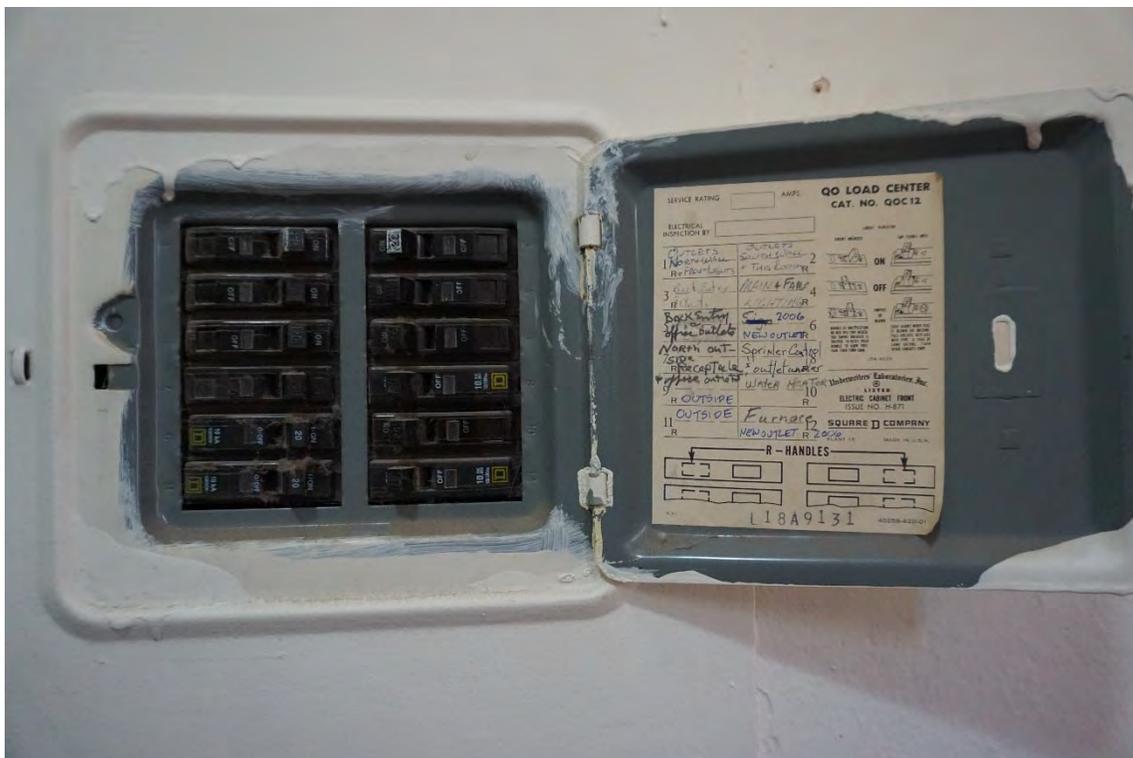
79.0 Electrical Panel – Located in Restroom/Kitchenette Addition

Phase IV - St. Rose of Lima				
Item	Quantity	Unit	Price/Unit	Total
SERIOUS DEFICIENCIES				
11. Install a new code compliant electrical service, electrical panel and an electrical upgrade.	1	ls	\$ 50,000.00	\$ 50,000.00

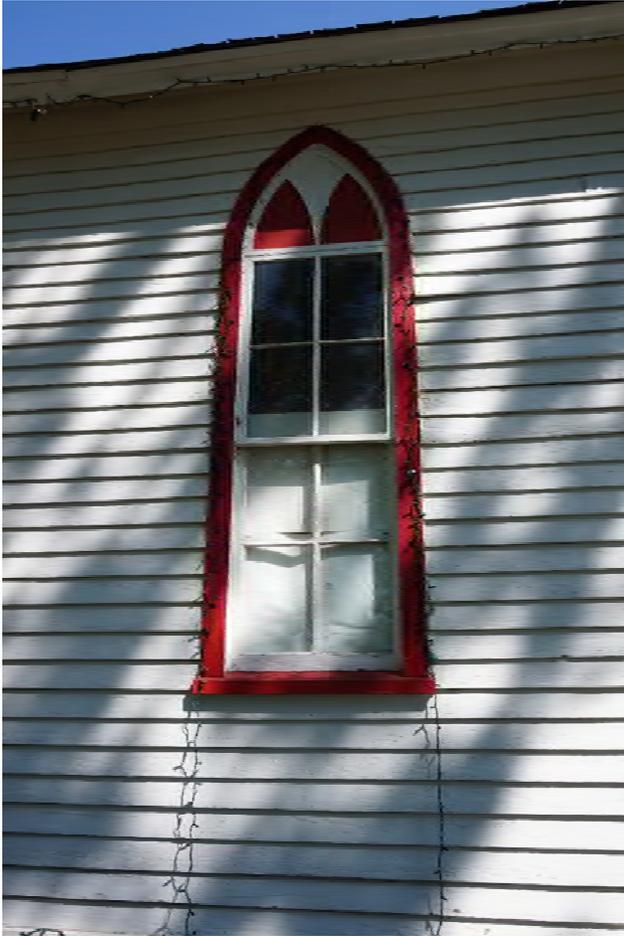
84.0 Window E

7. Restore Windows A, B, C, E, F, G, H	7	ea	\$ 2,500.00	\$ 17,500.00
8. Repair Window J	1	ea	\$ 1,000.00	\$ 1,000.00
9. Restore Window K	1	ea	\$ 2,500.00	\$ 2,500.00

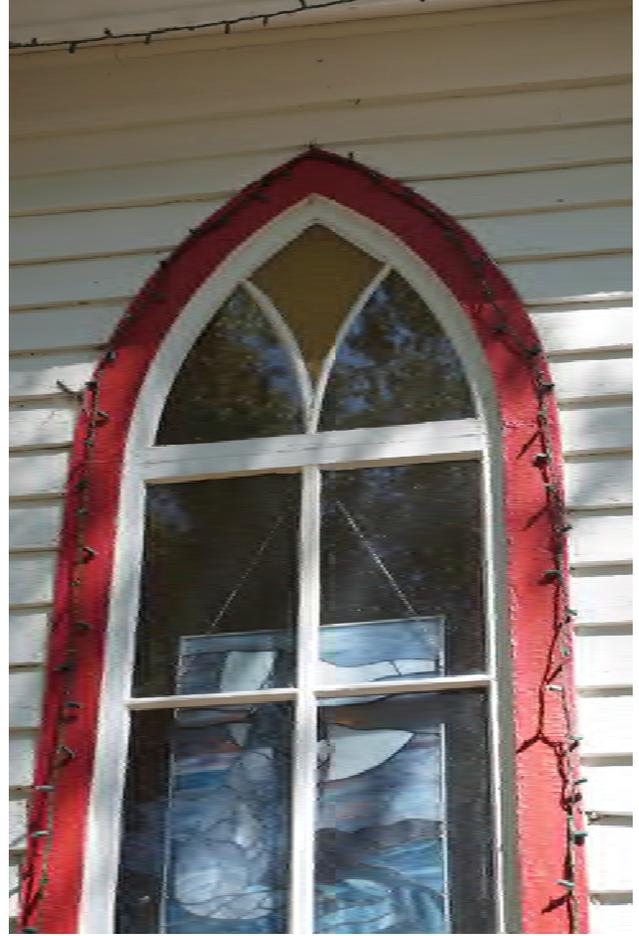
85.0 Window G
